EARTHQUAKE DISASTER PREVENTION OF CULTURAL HERITAGES - EXPERIENCE AND DEVELOPMENT IN JAPAN -

**August, 2023
ICOMOS Japan**

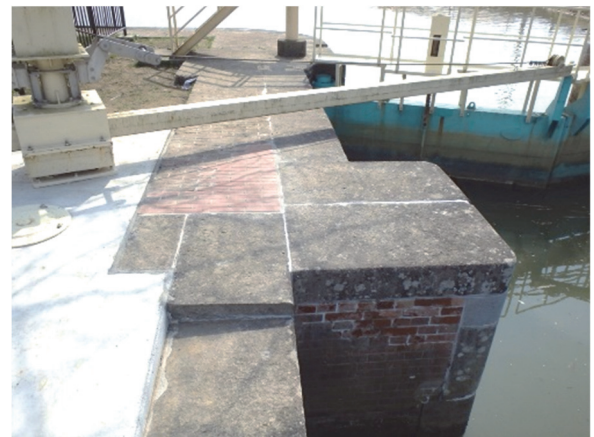
Damage conditions of the gate posts at the lock tail (left bank) after the switch gate was replaced

Restoration work on the gate posts at the lock tail (left bank)

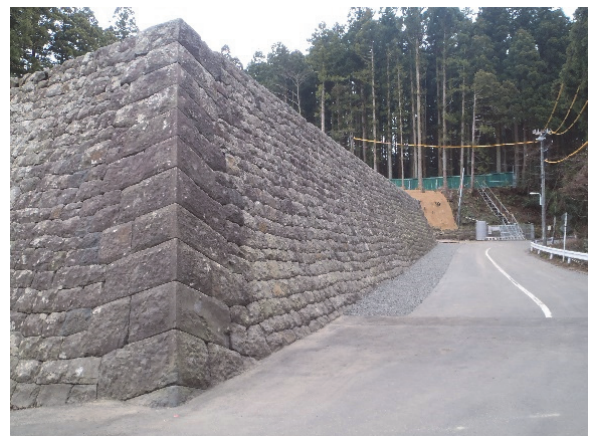
C-side of the northwest stone wall of the central compound after recovery

The c-side of the northwest stone wall of the central compound collapsed due to the Great East Japan Earthquake in 2011

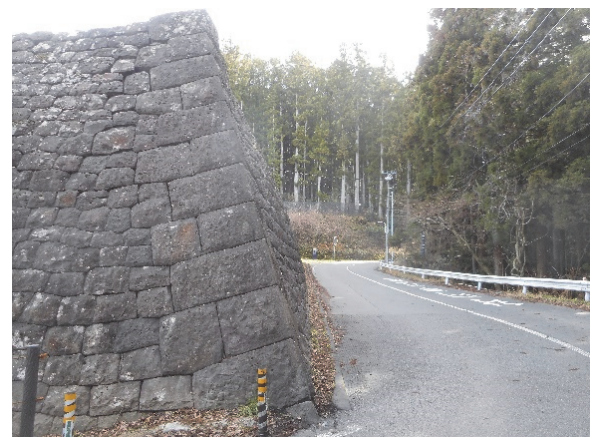
Deformation of the C-side stone wall northwest of the central compound caused by the Earthquake off the coast of Fukushima Prefecture in 2022

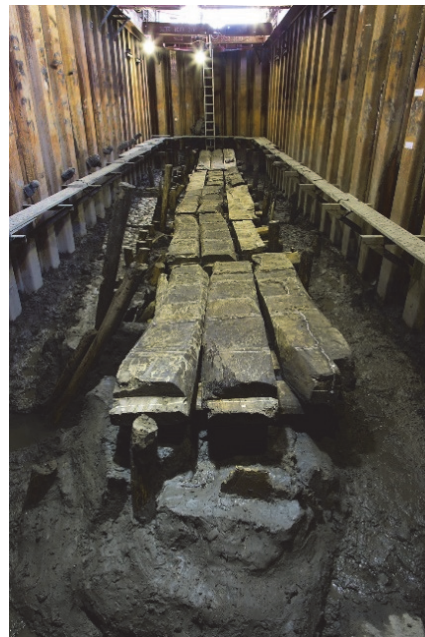
The wooden members of the foundation structure were judged according to their damage and decay after cleaning. The damage conditions were determined visually and measured with a measuring stick.

Condition of the foundation

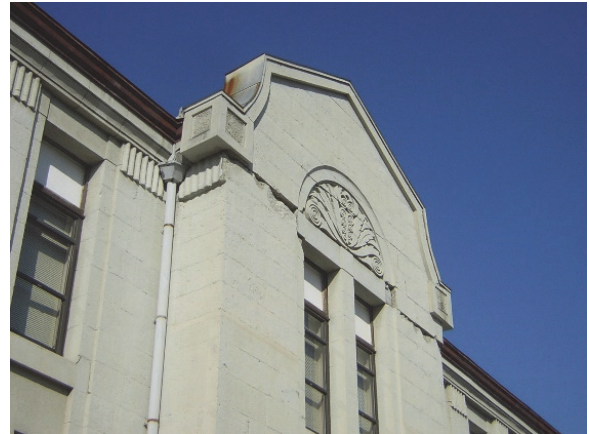
Damage of the pediment

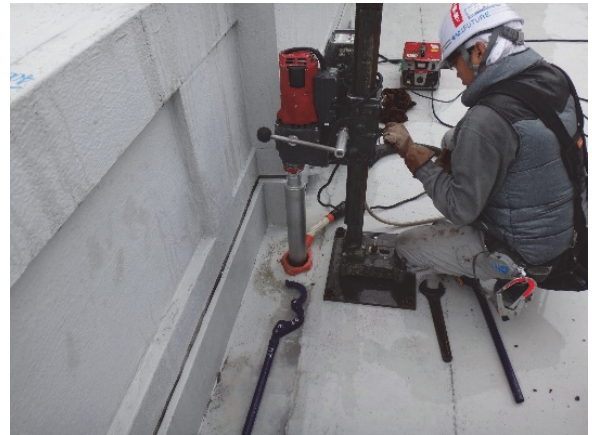
Damage to the wall

Insertion of deformed steel bars into brick wall

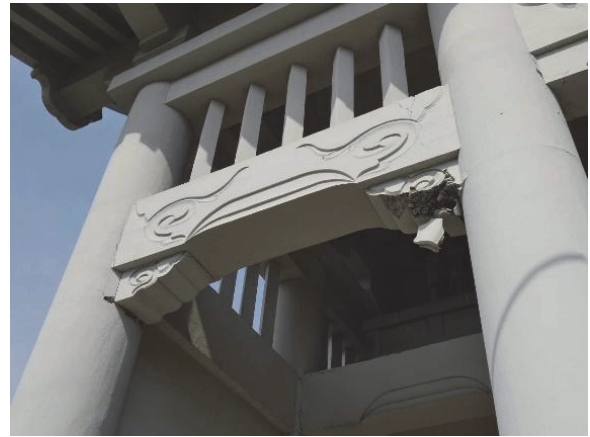
Damage to the column head, intermediate beam, and elbow section (east side: south side)

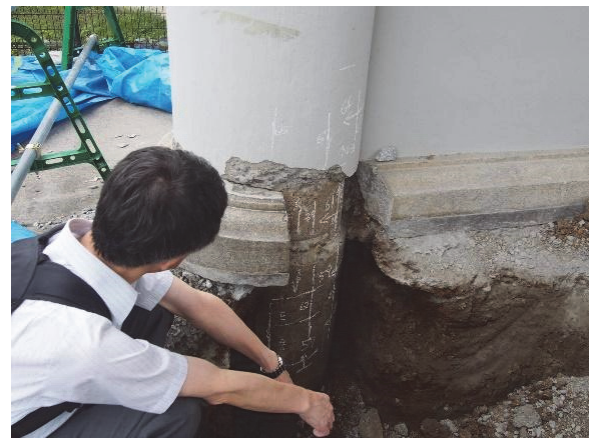
**Underground conditions around the column bases
(columns in the northwest corner)
(Photo courtesy of Mariko Nishijima)**

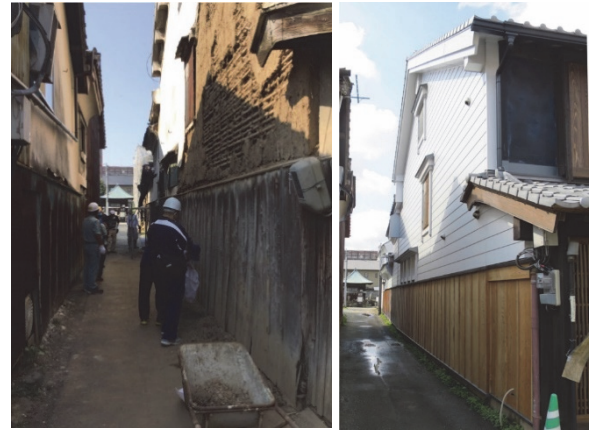
Damage to the alley side wall (left) and after restoration was completed (right)

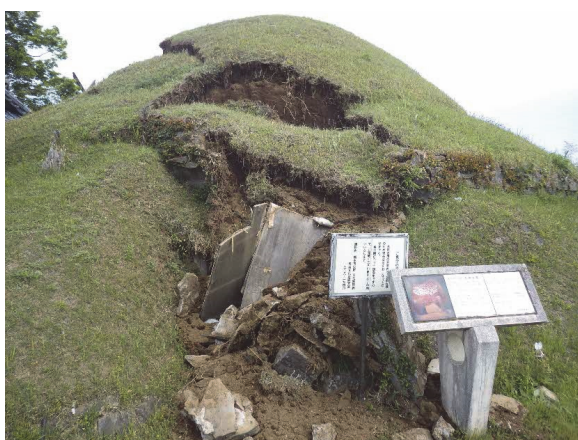
Collapsed soil blocking the entrance to the stone chamber (Photo provided by Kumamoto City)
