# Progress Report of Great East Japan Earthquake Recovery

Present State of Affected Cultural Heritage

5 November, 2014

Japan ICOMOS National Committee

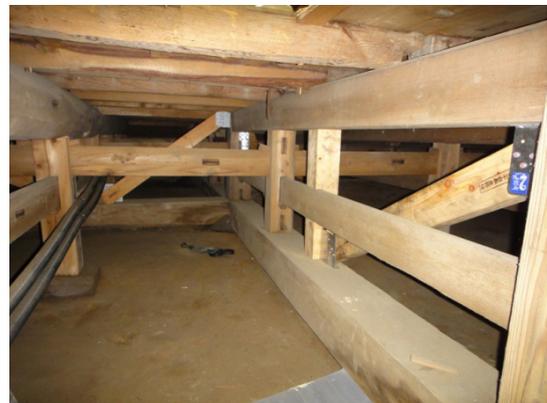
The Great East Japan Earthquake damaged the Seicho and Nobility Hall, with earthen walls falling on such areas as the portico. Results of structural analysis showed that reinforcement was necessary. These structures were seismically reinforced by introducing wooden braces in the floor structure; steel braces were installed in the roof structure, unifying the two buildings. This form of reinforcement employed reversible methods and was placed in areas hidden from view, so that the characteristic architectural designs of these structures would not be disturbed. Countermeasures were carefully taken with due regard to the value of these buildings as cultural properties.

Figure 2.2 Braces were introduced for reinforcement into the extant floor structure of buildings in the left photo

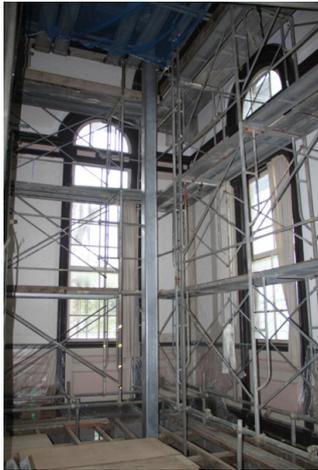
This assembly hall is a school building constructed in the late Meiji Era. The Great East Japan Earthquake caused many cracks in the wood lath and plaster wall and structural analysis revealed the necessity for seismic reinforcement. At first, it was planned to temporarily dismantle the walls for installation of reinforcement within. However, because this restoration was undertaken as a disaster recovery project, in order to keep the extent of construction work to a minimum, an alternative method had to be devised. Therefore, it was decided to place exposed steel columns inside the hall in the four corners, to be connected by steel-frame lattice beams hidden in the roof and floor structures. To keep the dimensions of the reinforcement columns small, comparably thin square pipes made of thick high-strength steel were employed. They were painted dark brown so as not to obstruct the historic interior. Though this method taken, with limits in

the area to be dismantled, resulted in visible reinforcement members, it was planned with care to keep influences on the interior design minimum.

Figure 2.4 Interior steel frame reinforcement of the Assembly Hall: Steel columns of 200-millimeter square were installed in the four corners

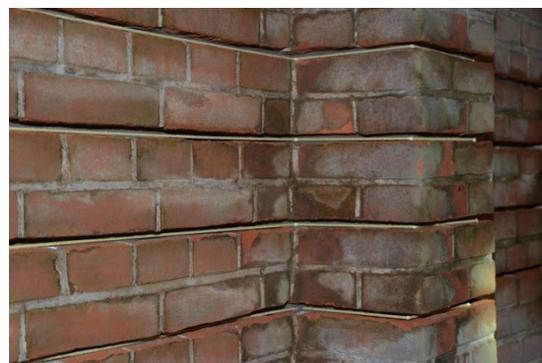
Within the premises of the wine distillery built in mid-Meiji era, the three structures of the office, fermentation room, and storehouse are nationally designated Important Cultural Properties. They are all brick buildings vulnerable to earthquakes, and at the time of the Great East Japan Earthquake, numerous cracks appeared on their walls. Particularly, the gable end of the washing room attached to the fermentation room was severely damaged to the extent of near collapse.

less steel rods were inserted into holes made in the top ends of walls, while mortar was removed from selected joints to be filled with aramid fiber of high tensile strength. For reinforcement of the entire structure, steel frame reinforcement was installed on the inside and outside, carefully choosing where they would be placed - within the non-designated area of the storehouse and behind the fermentation room - so that they would not be obtrusive to the view. These reinforcement members were designed with simple lines and in places equipped with interior lighting fixtures, in an effort to blend them into the historic environment.

Figure 2.6 Mortar joints of the brickwork were removed to insert aramid fiber for reinforcement

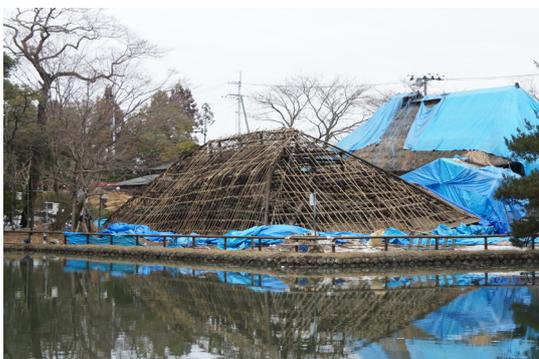
The Yubikan main building was undergoing refurbishment for wear and tear when the earthquake hit and caused it to collapse. We believe that the building would not have collapsed completely if the earthquake had happened after the restoration work was finished. Continuance of the work and further repair was delayed since the area had to be tested for radiation released from the Fukushima Daiichi Nuclear Power Plant. Rising material costs also affected the work schedule.

The remaining elements were dismantled entirely and we inspected them individually for the damage. After the inspection, we found light damage to the roof supports and floor joints but severe damage to the structural elements. In particular, horizontal elements such as threshold, head jamb, connection of vertical posts and horizontal beams were all seriously damaged. As for restoration we decided not to make changes to the original plan and bring them back to the condition of Meiji period. We will try to keep all usable original elements and replace only those that are not usable. Specifications followed traditional construction techniques and materials throughout the restoration work. The only exception is that on the east and south elevation, where wall elements were small and weak in structure, seismic reinforcements that would not affect the total design and value of the building were added.

Figure 2.7 Dismantlement of the roof

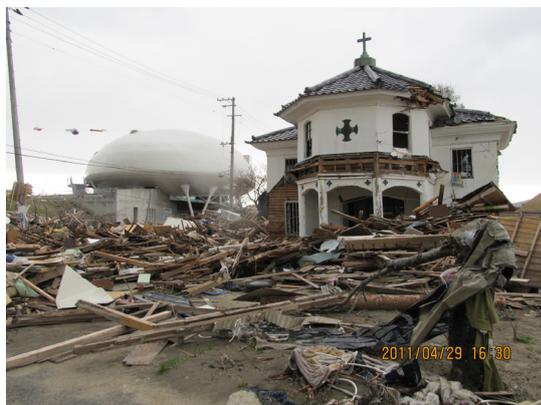
Former Ishinomaki Orthodox Church (Church of Saint Ioan the Apostle, located in Nakase, Ishinomaki City, Miyagi Prefecture) is a wood-frame two-storied church structure believed to have been built in 1880 (Meiji 13). Heavily damaged by the Miyagi Earthquake that occurred about one-hundred years later on June 12, 1978, this structure ended its life as a church. At that time, the structure was relocated from Sengoku-cho, its original location, to Nakase (a sandbank in Kitakami-kawa River) to house a museum and was designated as an Ishinomaki City Cultural Property. Though the building was again severely hit by the tsunami of the Great East Japan Earthquake on March 11, 2011, it luckily escaped total destruction and being washed away. With seawater having rushed through the building, almost all fittings were broken and most of the interior and ex-

terior finishes had fallen off, revealing the substrate. It was almost a miracle that the only major damage to the framework was breakage of a continuous column on the north façade.

Figure 2.10 Former Ishinomaki Orthodox Church after having braved the tsunami waters

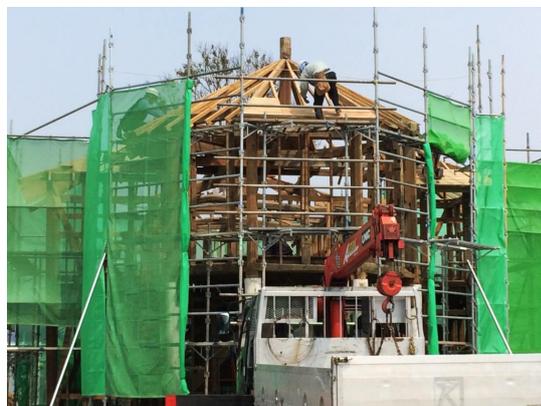
In 2014, damage surveys of structural members were made while dismantling the building by hand. Structural members that could be reused in the relocated and reconstructed structure also had to be selected through this process. Mainly, detailed measurements of structural members were taken; the members from the first relocation in 1979-1980 were identified; and surveys of traces on major members from the first relocation, to determine the building's original composition, were made. It was found that there were a few building members - columns and beams - from the original construction with a numbering system inked in Chinese characters. All members excluding those of the walls were renumbered to mark their locations for relocation, and the disassembled building was removed from the site, for storage in a prefabricated storehouse standing

Figure 2.11 The structure was carefully dismantled for relocation

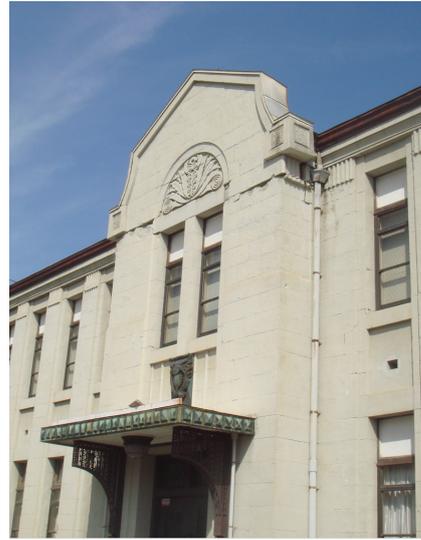
Fukushima City Museum of Photography is a two-story stone building, constructed in 1922. It is now a city-designated cultural property. The stone used for the building is called Kunimi Ishi, a type of volcanic tuff. A cementitious material was used for joints of 5 mm in thickness. The typical dimension of a stone block is about 50 cm to 55 cm x 85 cm x 35 cm. It is not certain whether some kind of connector was used for the joinery, but at least metal is not used. The framework of the truss is made of wood reinforced with steel for vertical load. Foundation is of reinforced concrete. Major damage found after the earthquake includes inclination and cracks in the decorative pediment above the entrance (Figure 2.19) and cracks and movement of the stone of the southeast corner (Figure 2.20). There were cracks at the corners of openings. Some plastering of interior walls fell as well. For safety reasons, the museum has been closed since the disaster occurred. In April of 2011, an investigation was conducted by the Architectural Institute of Japan. In November of the same year, Cultural Properties Doctor Dispatch Project also examined the building. From Dr. Mitsuji and his colleagues who monitored the microtremor of the building, we now know the natural frequency of the building is 3.5Hz in shorter direction and 4.8Hz in longer direction. The characteristic of this earthquake was that the short-period element was predominant even though the scale of the earthquake was very strong. Masonry buildings with short natural frequency like the Fukushima City Museum are particularly affected.

Figure 2.19 Damage on the decorative pediment above the entrance

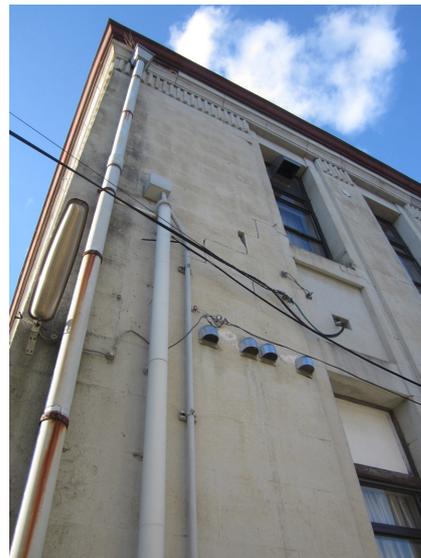
Figure 2.20 Damage on the stone of the southeastern corner

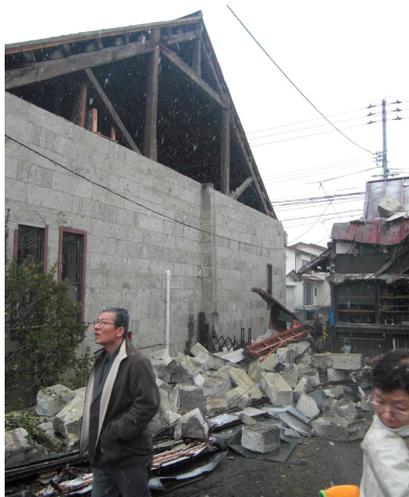
The biggest damage was sustained by the two masonry buildings and one large scale kura-style storehouse called tori-kura. As seen in Figure 2.22 the upper part of the gable side wall collapsed outward. As a remedial measure, wooden boards have been placed as seen in Figure 2.23. As of September 2014, one stone building is still closed to the public for safety reasons. The other stone building, which suffered a large crack on the unreinforced wall on the gable side, was restored and people began using after the crack was grouted and filled in remedial repair soon after the earthquake. The mud wall of the tori-kura (Figure 2.24) inclined 1/30 in the direction of the shorter beam. 17 wire ropes are now used to prevent further distortion. These restoration measures for progressive reinforcement were mostly finished by October 2012, but the plan for the stone building is still in progress. Restoration works for these buildings are supported by both the national and regional government. Additional support was also received from the World Monuments Fund in 2012.

Figure 2.22 The collapse of the stone wall caused by the earthquake

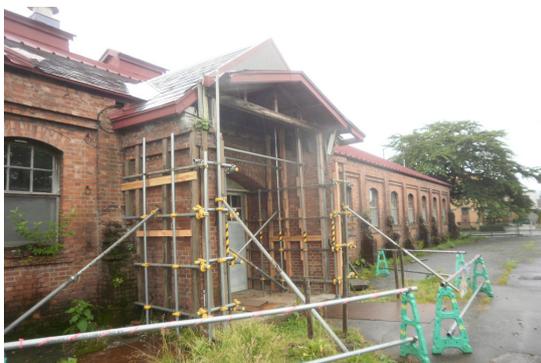
The Great East Japan Earthquake hit these buildings while their renovation construction was underway, causing distortion of the north wall and particularly severe damage, including cracks and distortion, in the waiting room at the north entrance (Figure 2.26).

A structural investigation was conducted in June 2011. By comparing the current conditions with records from a survey conducted in 2006 prior to the renovation construction, the investigation found the inclination of the walls and uneven settlement of the foundation to be relatively insubstantial. The roof trusses were all safe. Renovation construction was for a while interrupted by the earthquake but resumed afterward.

Figure 2.26 Damage to the brick counterfort and its emergency treatment

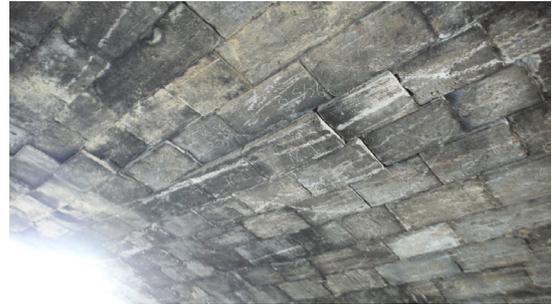
Tokiwabashi is a twin stone arch bridge that spans the Nihonbashi River in central Tokyo. Built in 1877, Tokiwabashi is now designated as a National Historic Monument. The bridge is 28.8 m in length and 12.6 m in width. During the Great East Japan Earthquake, the bridge sustained structural damage including rotation of arches, several cracks and displacements in the arch stones, bulging of spandrels, and depression of a part of the bridge floor.

Figure 2.30 Bulging of the arch stones

After inspection of the damage, it was decided that major repair incorporating the dismantlement of stone elements was required to restore structural stability. The project involves installation of falsework for safety and the implementation of research including laser scan and boring survey for documentation prior to restoration work.

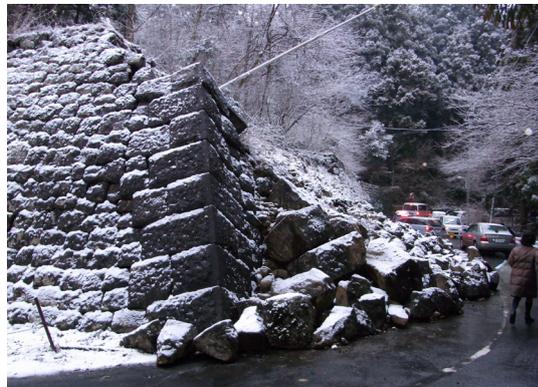
Figure 2.34 The northeastern wall of principal compound, immediately after the earthquake (taken on 2011/3/11)

is 200 m in length, 5 m in height. Apart from collapse in three locations, the entire wall is distorted. Restoration is carried out based on survey maps, photographs and position measurements made before the collapse. So far most of the fallen stones are back in place. Stone elements that had been broken or shortened during the previous restoration have been replaced by new ones.

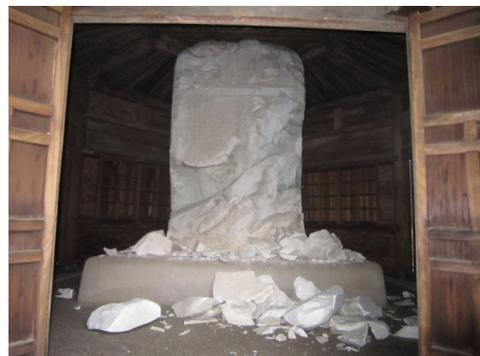
Figure 2.37 Damaged Kodokan stone monument due to the earthquake

monument was damaged by the bombardment at the end of World War II. The restoration was carried out to strengthen the stone monument by installing concrete plate behind it. The research results revealed that the installation of concrete plate behind the stone monument at the previous restoration had a bad effect during the vibration due to the earthquake. The following procedures were decided by the committee of experts for the restoration. The stone monuments and concrete plate was moved to the restoration facility and the concrete plate was removed. The stone monument was strengthened by using stainless steel rod, aramid fiber and epoxy resin. The broken surface stone with inscriptions were returned to the original position and strengthened with inorganic adhesive. The concrete cover of stone base applied at the previous restoration was removed and strengthened by using epoxy resin. In order to make the stone monument anti-earthquake structure, barycenter of the monument should be lowered and it is necessary to increase the moment to resist against the moment induced by the earthquake force. Based on the results of structural analysis, the stone monument and base stone was firmly glued. The restoration program was completed in fall of 2013 (Figure 2.38).

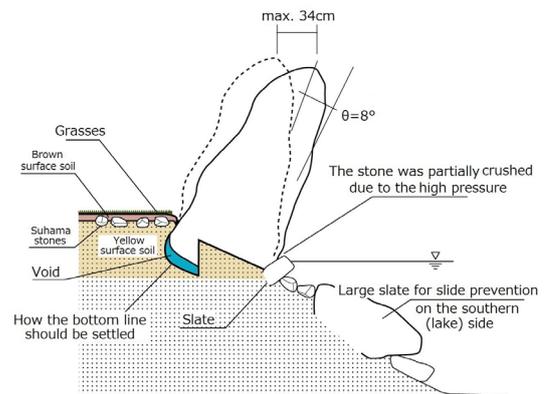
Fig. 4.1 Conditions of the disaster-affected standing rock and its rescue measures

The standing rock was carefully hoisted by chain block at an angle. A mixture of clay and new stone was used to fill a void that had resulted from earthquake damage, and the rock was returned to the position where it was surveyed in 1990. The excavation survey, which was the first of its kind to be conducted in the said area, provided new knowledge on traditional garden construction techniques, including methods used for erecting the rock and creating the island. Through successful restoration, the value of the standing rock and island has been preserved.

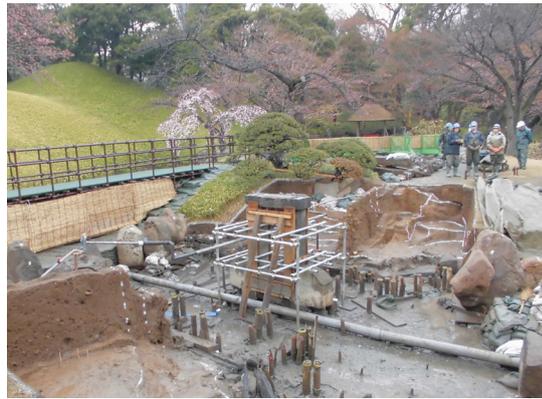
The East Japan Great Earthquake, which occurred March 11 2011, damaged parts of this historic garden, including a stone bridge situated on the major visitor trail in the garden. It was decided to restore the bridge and, prior to recovery works, on-site investigation was conducted, which resulted in the new findings of the historical changes in the location, material, and structure of the bridge (remains of an old wooden bridge were discovered) and also the records of past earthquakes in the pond together with those of reactive measures that have been taken historically such as earth filling after earthquakes.

Figure 4.5 Survey of the stone bridge
