The Kumamoto Earthquake

Report on the Damage
to the Cultural Heritage

1 December 2017

Japan ICOMOS National Committee

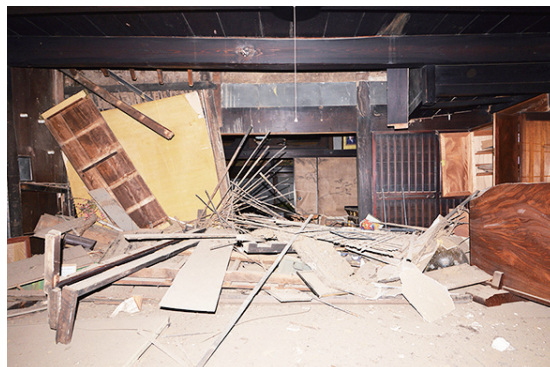
Photo 3.1.1.8 Interior of the main building, the *hiroma* (after the earthquakes)

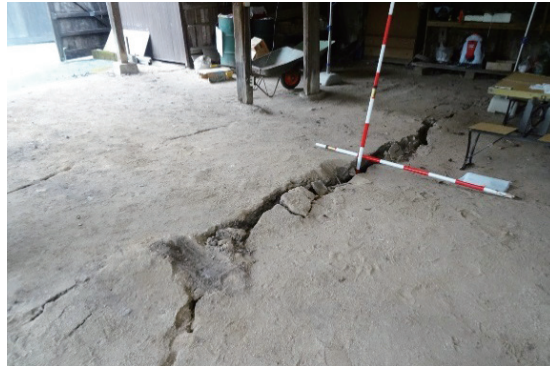
Photo 3.1.2.2 The fissure at the shed of the Yano family home (*Hontaku*)

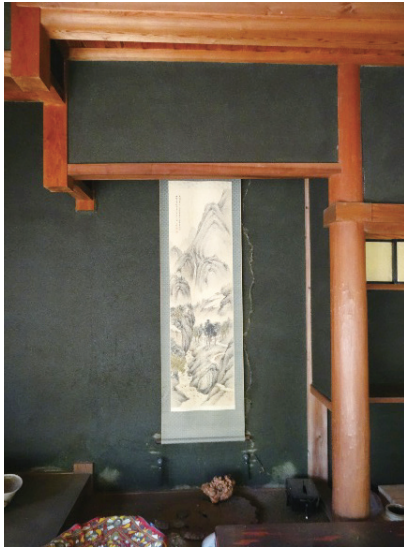
Photo 3.1.2.13 A fissure in the wall of the alcove of the Yano family home (*Shintaku*)

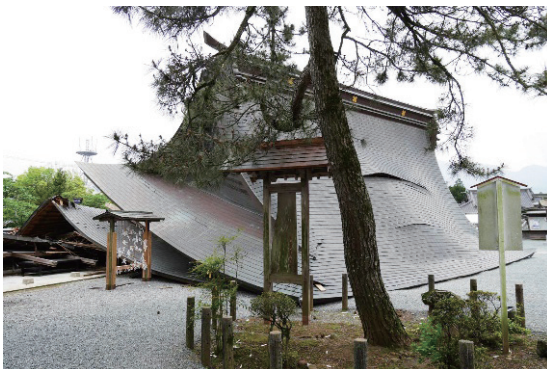
The Romon Gate, which was one of the Three Greatest Romon Gates of Japan, had an upper structure that was extremely impressive. The main-shock earthquake that struck the Aso region on April 16th registered a weak 6 on the Japanese seismic scale and the Romon Gate is considered to have collapsed due to the inclination of the columns caused by the tremors and the P-Δ effects resulting from the heavy weight of its upper part.

Photo 3.1.3.1 The collapsed Romon Gate of the Aso-jinja Shrine (the roadside approach).

The policy for the repair works of these buildings, which have been designated as Important Cultural Properties, is repair through dismantling for the Romon Gate and through partial dismantling for the other damaged buildings. The work began in Heisei 28 (2016) and is scheduled to continue until Heisei 35 (2023). (Photos 3.1.3.1-5 Taken by the author.)

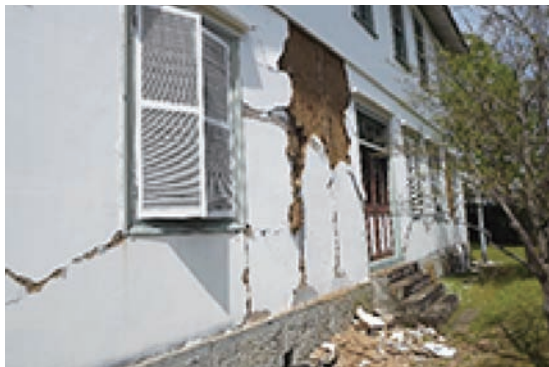
Photo 3.1.6.2 The damage caused by the fore-shock earthquake (rear).

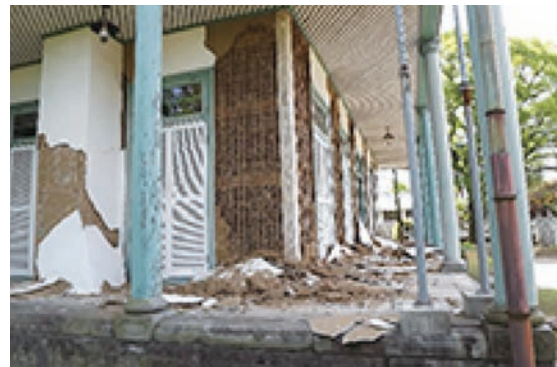
Photo 3.1.6.3 The damage caused by the fore-shock earthquake (left front).

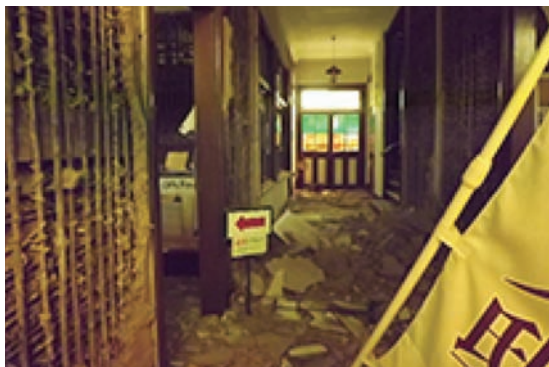
Photo 3.1.6.4 The damage caused by the fore-shock earthquake (interior).

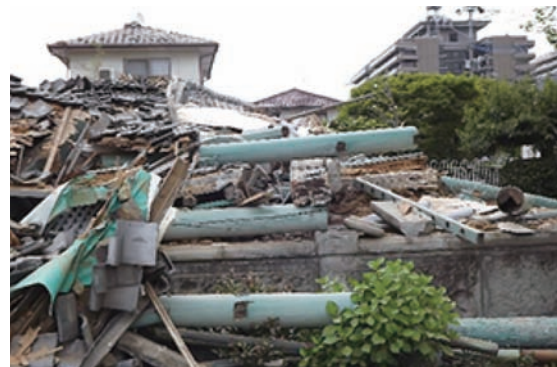
Photo 3.1.6.5 The building was completely destroyed in the main-shock earthquake (1).

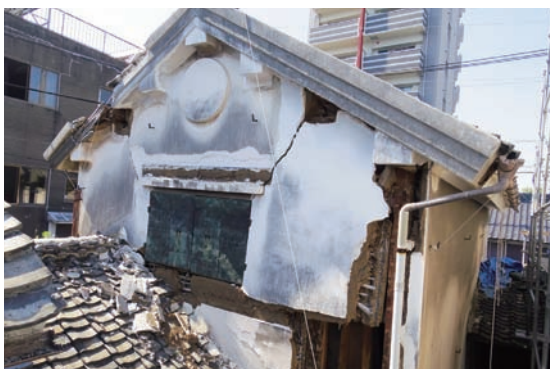
Photo 3.1.7.3 The damage to the warehouse (south side).

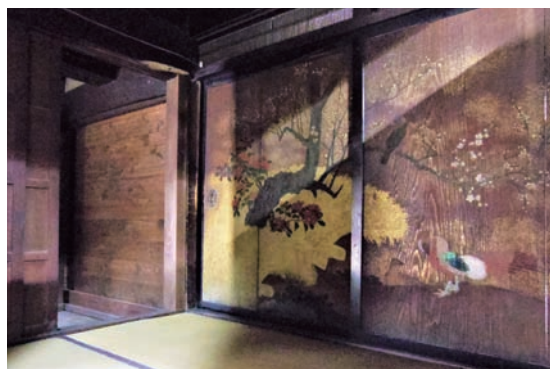
Photo 3.1.7.4 Additional earthquake-resistant walls (left side of the wooden door).

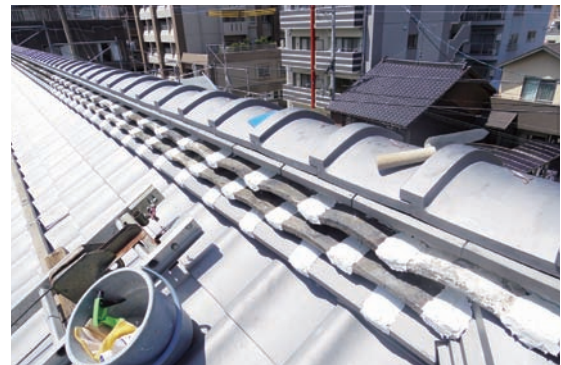
Photo 3.1.7.6 Restoration of the large building using the original tiles (main building).

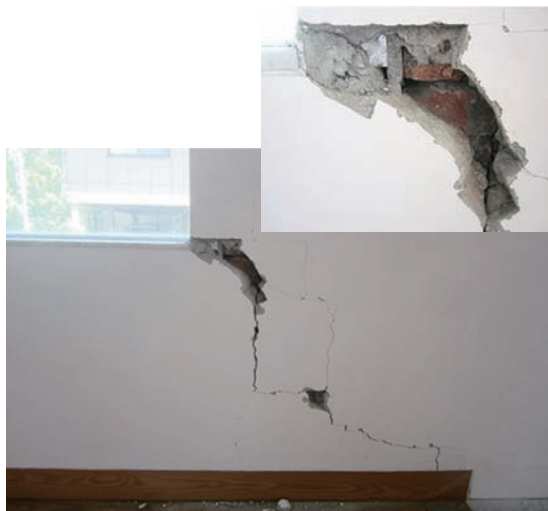
First, cracks appeared in the brick wall (inner side), with cracks appearing around and in the corners of the openings (See Photo 3.2.1.3). One of the characteristic movements of masonry structures during an earthquake has been found to be deformation in the form of expansion toward the outsides of the corners. In this building, too, cracks

Photo 3.2.1.3 Cracks appeared around the openings.

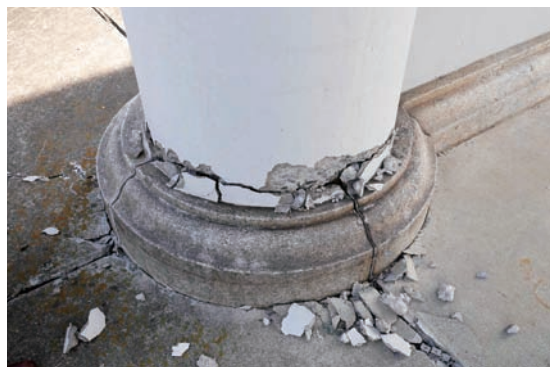
Photo 3.3.1.4 Honmyo-ji Nio-mon: damage to a column base.

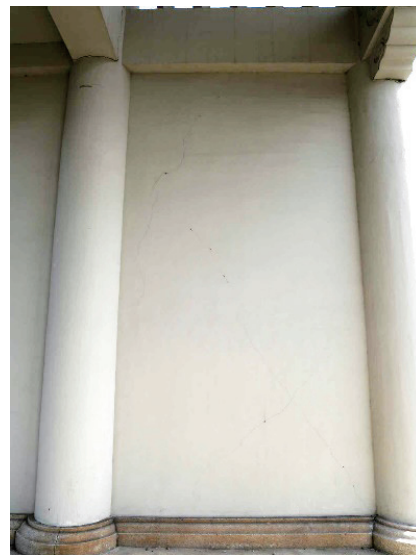
Photo 3.3.1.6 Honmyo-ji Nio-mon: shear cracks in the walls.

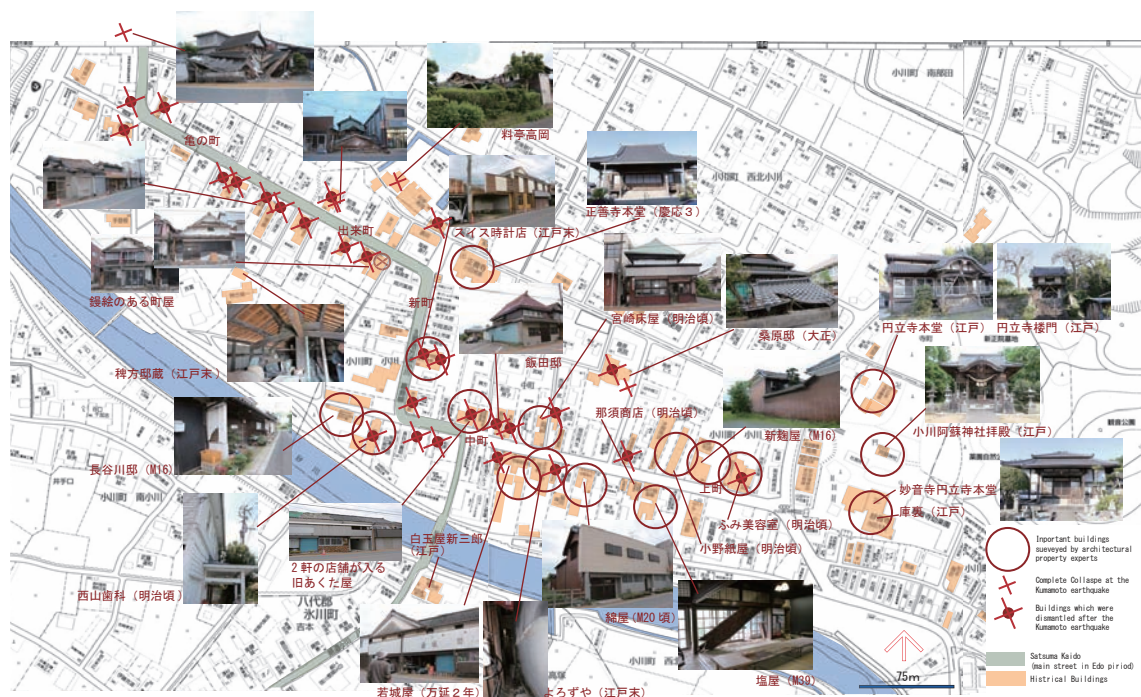
Photo 3.4.3.6 The damage situations at the traditional townhouses in Ogawa Town's commercial district (August 2017).

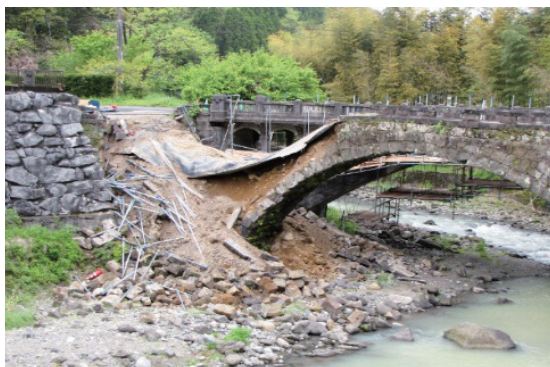
Photo 3.6.1.2 The collapsed stone wall at Futamata Fuku-ura-watashi

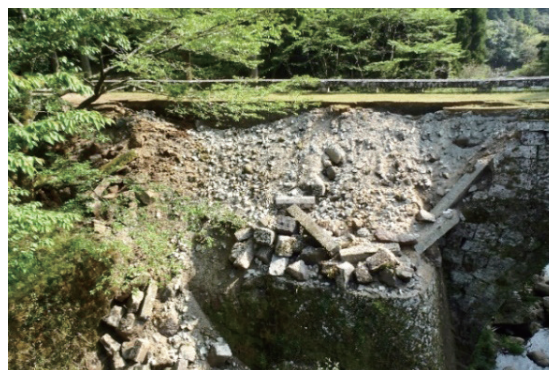
Photo 3.6.1.4 The stone wall on the upstream side collapsed at the Yasemegane Bridge (Photo by Mifune town)

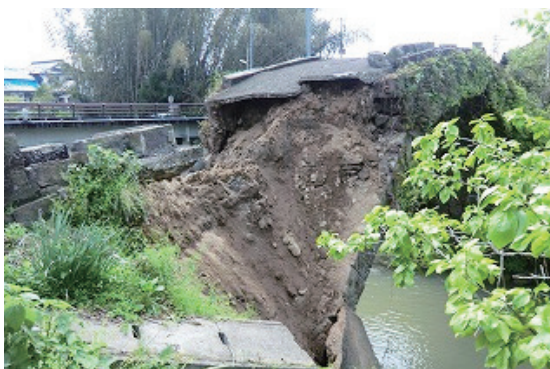
Photo 3.6.1.5 The stone wall collapsed at the Yasumi-shimoduru Bridge (Photo by Uki city)

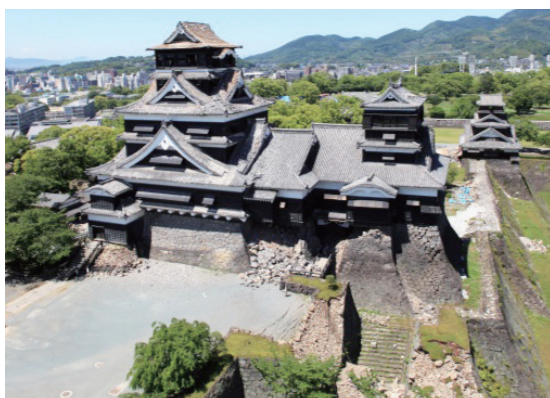
Photo 3.7.1.2 The damaged castle main keep

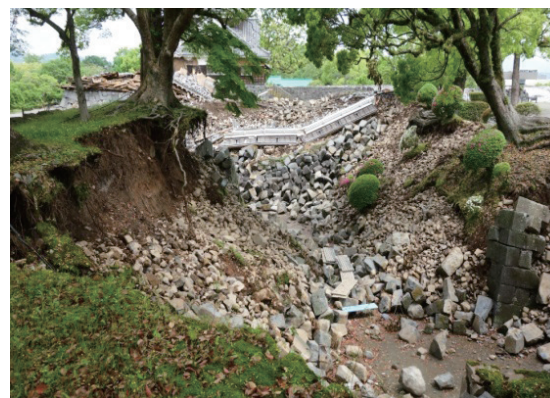
Photo 3.7.1.3 The damaged Sukiymaru Gate site (from the South)

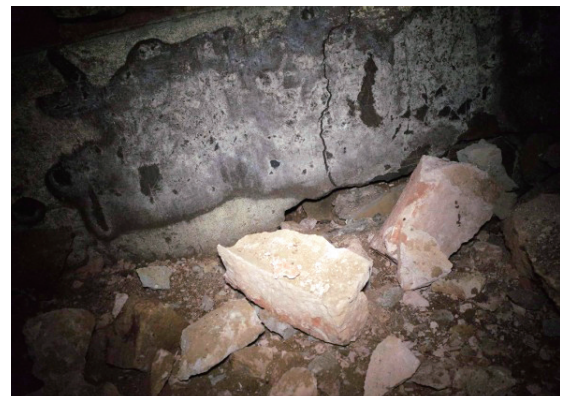
Photos 3.7.2.1 The Idera Kofun: Fissure in the mound and damaged stone chamber (courtesy of Kashima Town Board of Education).

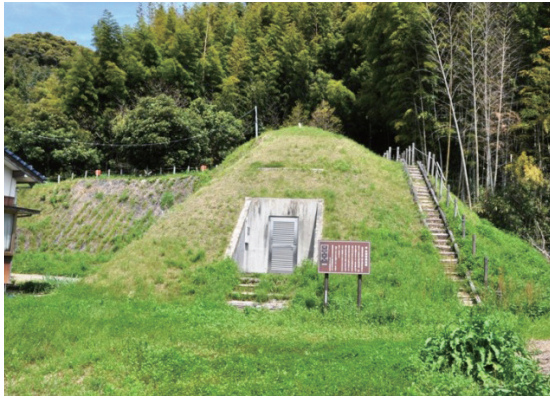
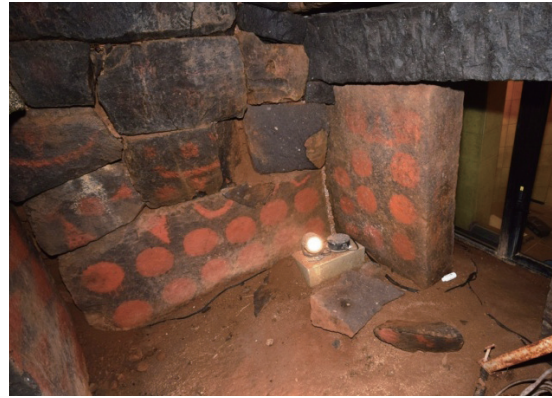
Photos 3.7.2.2 The Eianji Higashi Kofun: The damaged mound and stone chamber (courtesy of Tamana City Board of Education).

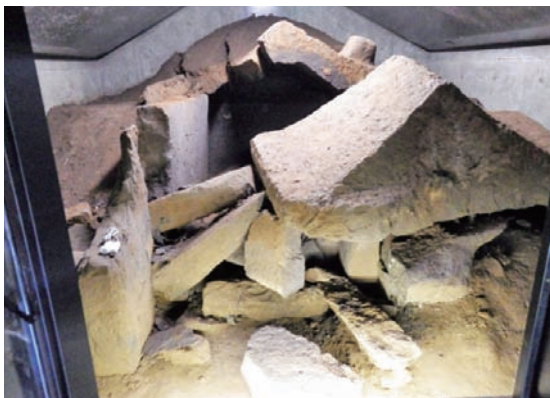
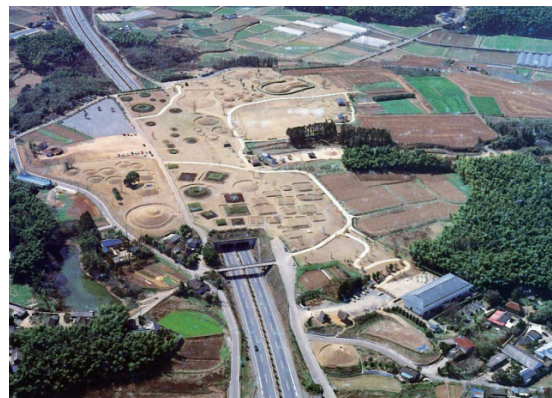
Photos 3.7.2.3 The damage in the Ishinomuro Kofun stone chamber and an aerial photo of the Tsukahara Kofun Group (courtesy of Kumamoto City).
