EARTHQUAKE DISASTER PREVENTION OF CULTURAL HERITAGES - EXPERIENCE AND DEVELOPMENT IN JAPAN -

**August, 2023
ICOMOS Japan**

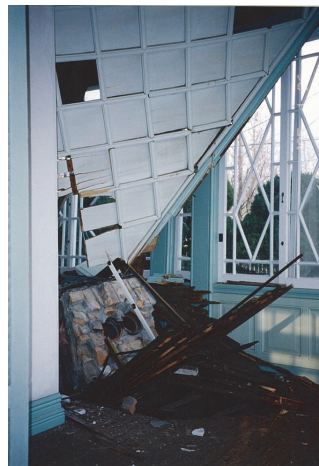
Photo 2.12 An example of a chimney that fell indoors (Former Hunter Residence)
(Photo provided by Agency for Cultural Affairs)

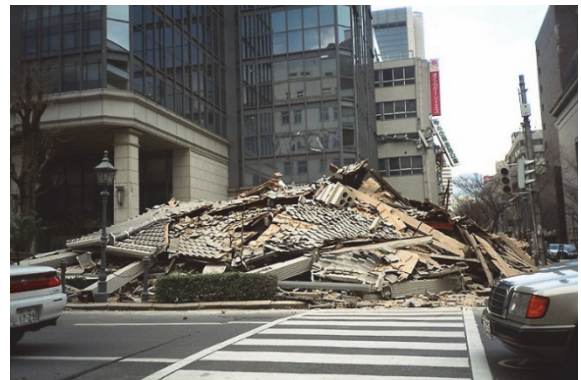
Photo 2.1.6 Damage situation of the former Kobe Settlement 15th Building < National Important Cultural Property>
(Building ownership: Nozawa Corporation, Photo provided by Kobe City Museum)

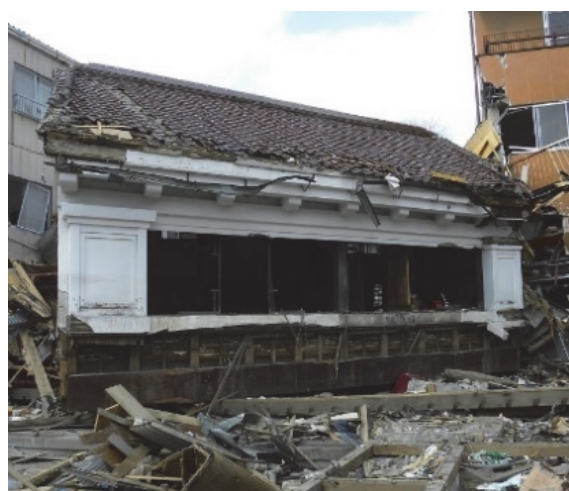
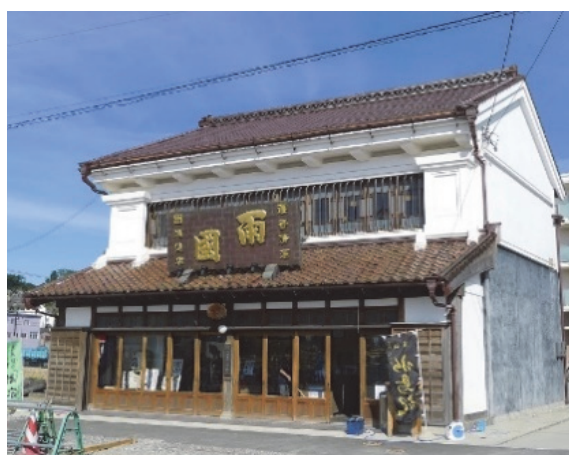
Photo 2.2.1 The Kakuboshi Sake Brewery Store registered cultural property after the Great East Japan Earthquake and tsunami (above) and after rehabilitation (below)
(Photo courtesy of Shigeki Sekiguchi)

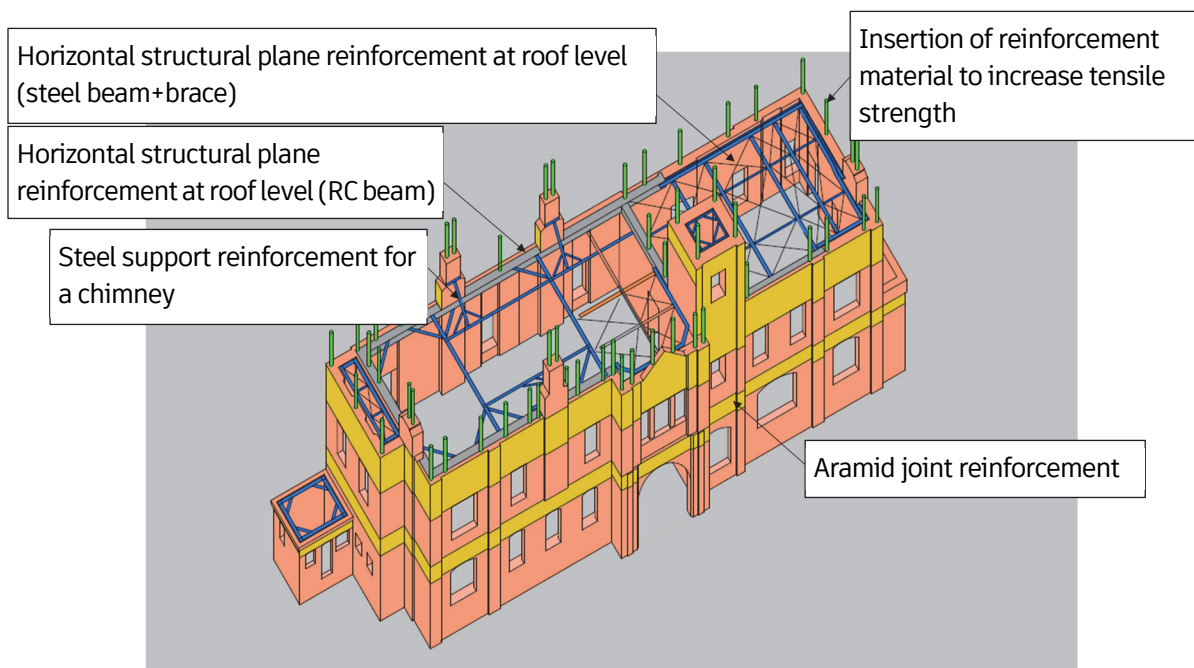
Schematic reinforcement plan

For the office building, we placed special emphasis on the exterior and interior design and considered methods that would have as little impact on the design as possible. Reinforcement methods included: (1) Inserting vertical steel rods into the brick walls and stabilizing them with grout, (2) placing steel framing on a section of the first floor, (3) adding reinforced concrete beams, steel beams, and wooden truss to reinforce the horizontal structural plane at roof height, (4) installing structural plywood plates to reinforce the horizontal structural plane at the height of the second floor, and (5)

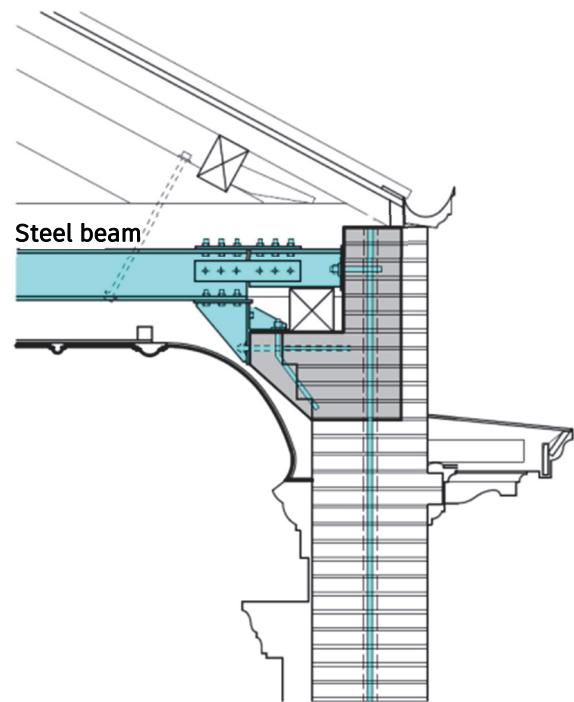
Detailed reinforcement diagram

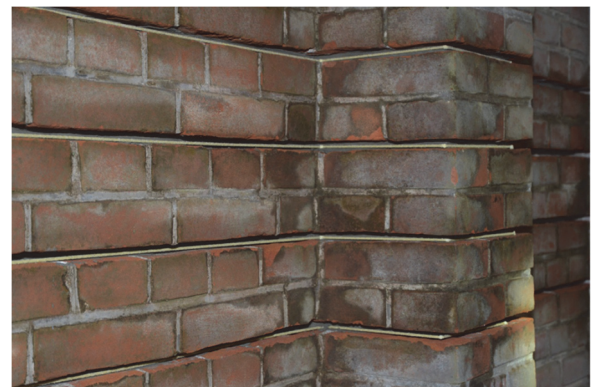
Reinforcement of the joints, Office Building

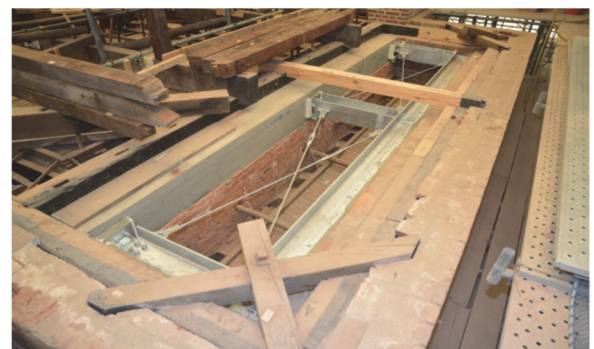
Installation of reinforced concrete (RC) beams

inserting stainless steel rods and a steel brace to reinforce the chimney. The necessity of installing reinforced concrete beams at the roof level was discussed carefully since removing a portion of the top

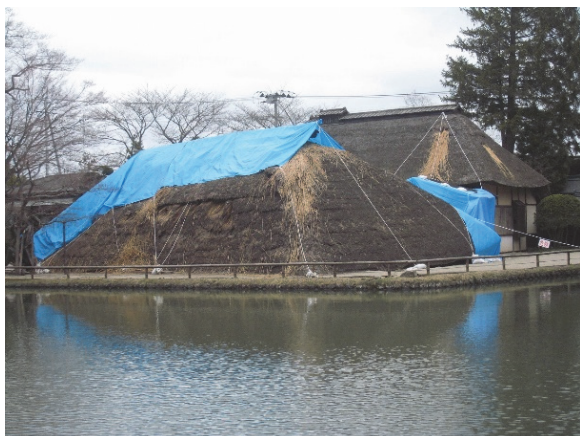
preservation repairs that included structural reinforcement because of the many openings and lack of seismic elements inside the building. When the design for the basic seismic reinforcement and conservation repair work was completed, the Great East Japan Earthquake in March 11, 2011, caused the main building to collapse, damaging the annex building, the main gate, and part of the garden. The main building collapsed toward the southeast, with almost all columns broken and walls collapsed so that the eaves of the roof trusses touched the ground. The building was closed to the public following the results of the seismic assessment, so no human casualties were sustained in the collapse.

Other buildings (the annex buildings, corridor, tea ceremony house, and main gate) had distorted shafts and partially collapsed walls but did not collapse. In the garden, the ground subsided behind the pond embankment, and damage and cracks were observed in the garden paths.

South view, damage conditions (main building in front, the annex at the back)

In the recovery process, the main building was repaired with full-scale dismantlement, and the annex and corridors were repaired with partial dismantlement. The dismantled materials were temporarily stored in the preservation shed, and not only the original structures but also the replacement materials were repaired and used if possible. The tree species of the new replacement materials were identified, and species matching the original materials were used as much as possible. If they were difficult to obtain, the material was substituted.

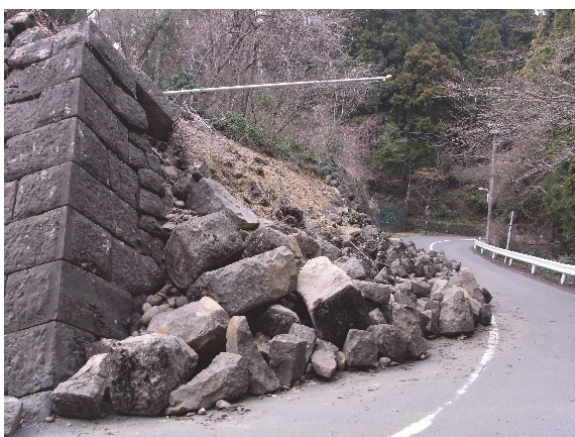
The c-side of the northwest stone wall of the central compound collapsed due to the Great East Japan Earthquake in 2011

Regarding the restoration after the Great East Japan Earthquake, since the Sendai Castle Site is a nationally designated historic site, we aimed for the restoration to reach a state as close as possible to the pre-damage, original state, using traditional construction methods as much as possible. Following this policy, the north stone wall of the Nakamon Gate, which was renovated in 1977 by altering staking techniques with a non-traditional method using concrete, was restacked to the traditional dry masonry form by removing the concrete. The earthen wall on the north side of the Otemon gate had been renovated with mortar during the recovery from the Earthquake off the coast of Miyagi Prefecture in 1978, so the entire surface was removed and the wall was restored using traditional dry masonry. In the recovery of the collapsed earthen wall,

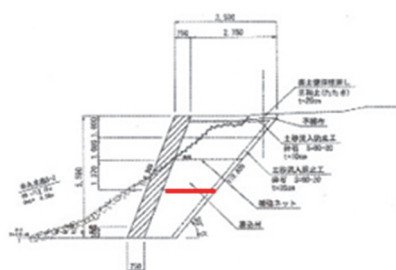
(Construction diagram of geotextile reinforcement northwest stone wall of the central compound)

the remains of the castle were preserved, and some modern construction methods were adopted in order to build within the scope of modern era construction. Regarding the construction method, several layers of synthetic fiber reinforcement nets (geotextiles) were inserted into the backfilling stone layers for the recovery work to reduce the earth pressure.

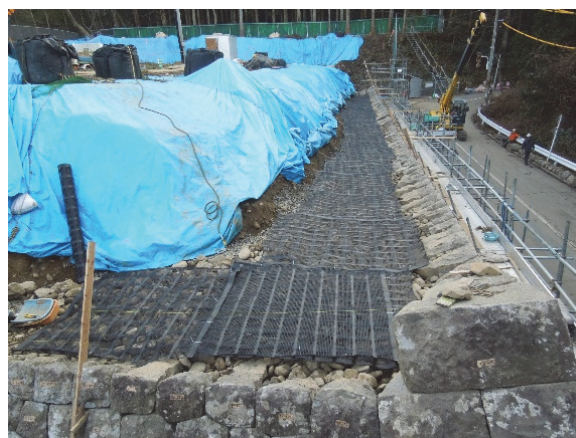
Geotextile reinforcement work at the C-side of the northwest stone wall of the central compound

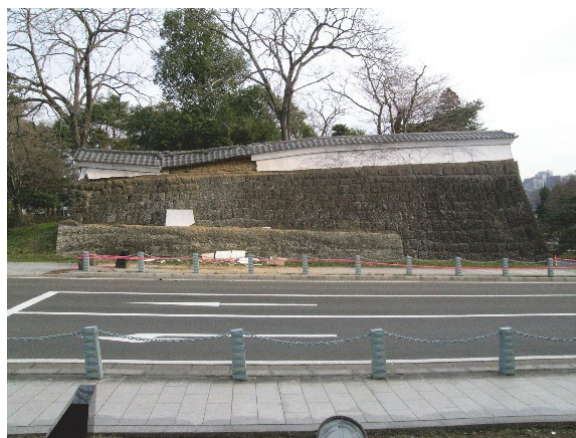
Earthen wall on the north side of the Otemon gate collapsed by the Great East Japan Earthquake

the clay and roof tiles used for the wall were collected and reused. It was found that the bases of the north stone wall of the central gate and the northwest stone wall of the central compound had been raised with mortar where the footstones partially subsided. Since the mortar could deteriorate over time and be damaged by the load, it was removed and replaced with new, tall manufactured stones. While recovering the collapsed stone wall, we identified the location of each stone material based on past survey maps, photographs, and location maps that recorded how the collapsed stones were scattered, and re-stacked them in their original positions to the extent possible. In the recovery work, the damage conditions made it necessary to determine how to ensure visitor safety in the event of future earthquakes. In particular, the need to strengthen the stone walls for future earthquakes was discussed regarding the southern part of the northwest stone wall of the central compound, which is close to the city road. As a countermeasure,

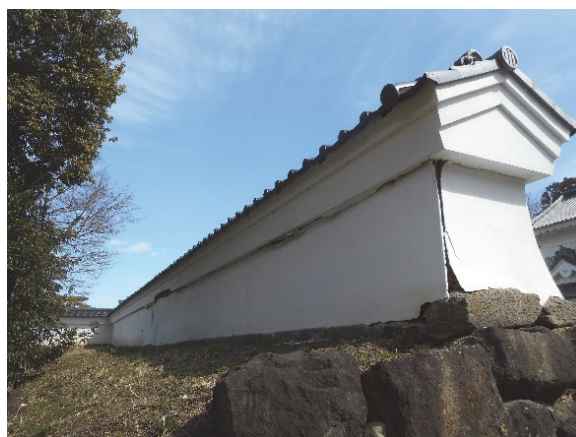
Earthen wall on the north side of the Otemon gate deformed by the Earthquake off the coast of Fukushima Prefecture in 2022

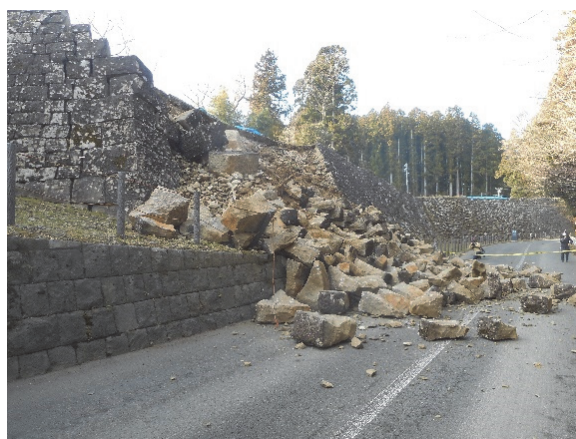
The stone retaining wall in the area where the reinforcement net was placed during the recovery from the Great East Japan Earthquake was 5 to 6 meters high. We initially planned to insert about 5 tiers at 1-meter intervals, but due to the importance of traditional construction and the uncertainty of how introducing this construction method would affect the stone wall itself in the event of an earthquake, we decided to insert 2 to 3 tiers as the minimum number of tiers that would maintain stability in the event of an earthquake of the same magnitude as that of the Great East Japan Earthquake. As a result, the collapse was avoided even with the 2021 and 2022 earthquakes of seismic intensities of upper 5 in, but the structure was greatly deformed and required re-construction. Future issues to be addressed include the appropriate number of reinforcement nets to be used, their fabrication method, and how to connect (integrate) them with the ground or rear embankment layer. It is necessary to fully discuss and examine whether the existing remains can be reinforced without damage. If that is not the case, it is necessary to coordinate the preservation of the cultural properties and the

Northwest stone wall E-side of Central Compound (Main Compound) that collapsed again after the Earthquake off the coast of Fukushima Prefecture in 2022

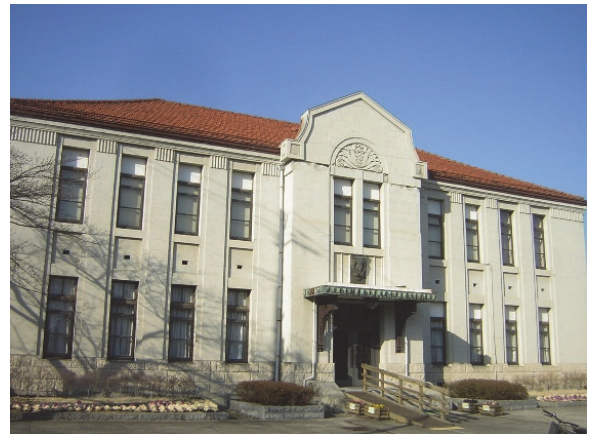
View after the recovery

struction methods. To improve seismic performance, the following measures were taken: (1) building a new foundation, (2) placing horizontal braces on the second floor, (3) placing laminated wood (500mm x 200mm) beams at the top of the masonry walls, (4) inserting high strength steel bars ($\phi 23$, prestressing (PS) = 50 KN, 47 bars) into the masonry walls, and (5) supporting the pediment with a steel frame. The Ministry of Education, Culture, Sports, Science and Technology's Disaster Recovery Project for Public Social Education Facilities was used to finance the recovery work.

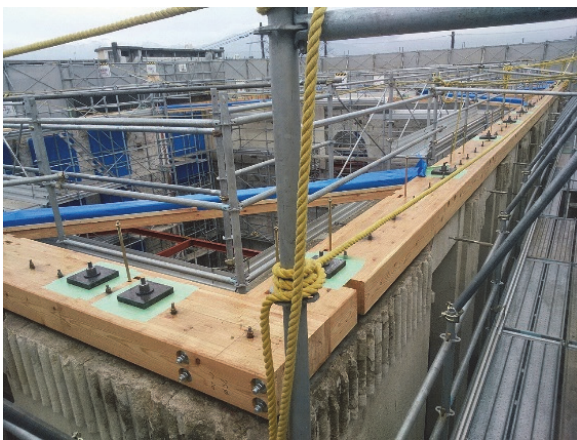
Laminated wood beams above the walls

Since there are reports that reinforcement with rigid reinforced concrete induced damage during the 2009 L'Aquila earthquake, laminated wood from Fukushima Prefecture was used for the beams above the walls. Since these laminated wood beams supported the tops of the high strength steel bars, the loosening of the prestress over time became an issue. In addition, monitoring of the prestressing value of the installed high strength steel bars is being monitored as of 2022.

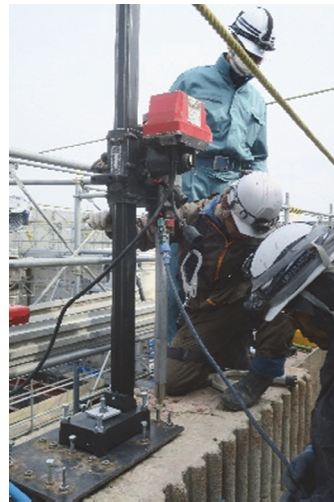
Drilling holes in the masonry wall

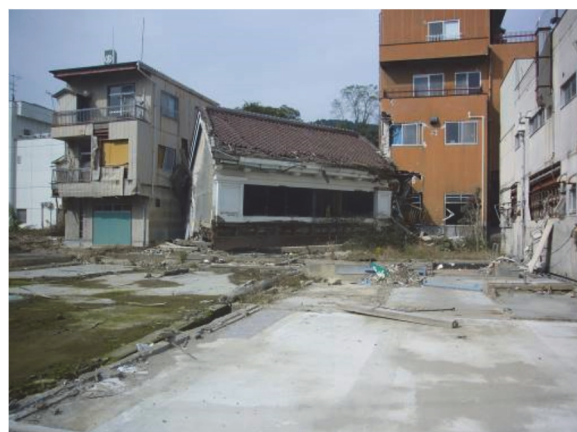
The first floor was washed away by the tsunami of the Great East Japan Earthquake, and the second floor was swept away to the north about 30 meters from its former location. The house was temporarily moved to the pre-disaster site and cured until the land readjustment project policies were established and restoration became possible. In the end, the restored building was moved approximately 8m west of the pre-disaster site due to land conversion and site shape changes. The restoration work was completed in September 2016, the first of the six cultural property sites in the Kazamachi district.

The tsunami swept the first floor away and pushed the second floor about 30 m north

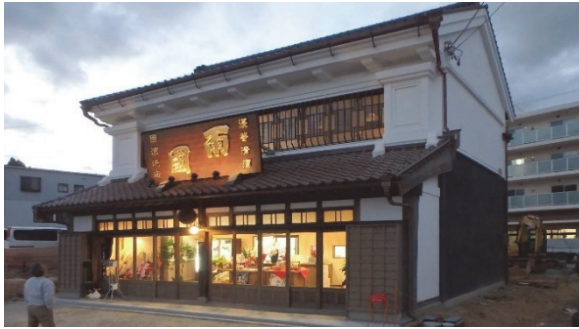
After restoration (September 2016)

First, the rescued second-floor components were dismantled and stored, and at the same time, a search and investigation of the lost materials was conducted. Original materials were reused as much as possible. The remaining roof trusses, second-floor posts, beams, girders, baseboards, rafters, floorboards, walls, ceiling materials, copper grids, and some other materials found in the surrounding area were all reused, and the lost first-floor posts, floor joists, and severely damaged eaves were replaced with new materials. The exterior finish was, in principle, restored. All of the exterior plastering,

however, was newly replaced, and the newly constructed stairwell was sprayed with a ricin finish to distinguish it from the original materials. For the roof, decorative end-tiles and recovered tiles were reused, and the rest were collectively used for the shed roof. The ridge design was restored to the *sei-gaiha* or repeating wave style using old photographs as a reference.

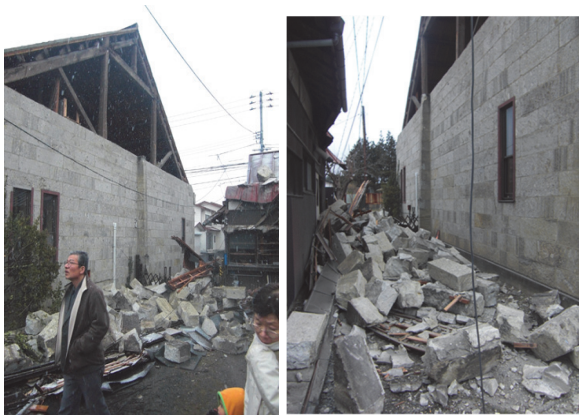
**Former rice storing and milling house
(collapsing stone walls)**

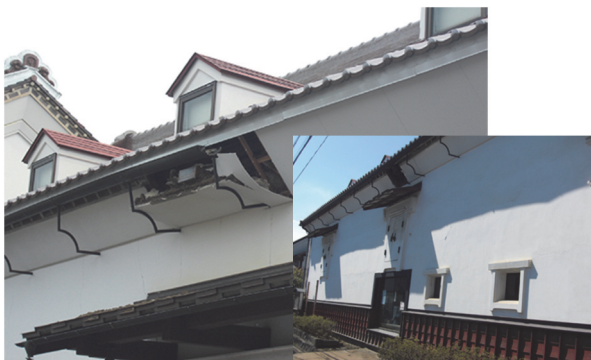
**Former sales warehouse
(inclined building and damaged eaves)**

The building was tilted 1/30 radian in the beam-to-beam direction by the Great East Japan Earthquake. In addition, the eaves were damaged. Subsequently, the tilting was forcibly corrected using wires, and the roof trusses were reinforced with wood. However, the March 16, 2022, the Earthquake off the coast of Fukushima Prefecture struck again, damaging the eaves and falling roof tiles. The building is used as a store and office.

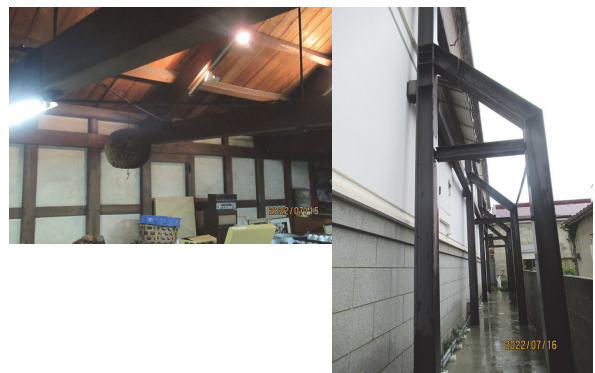
Steel buttress and truss reinforcement to increase horizontal rigidity in the former sake brewing warehouse and sake starter house

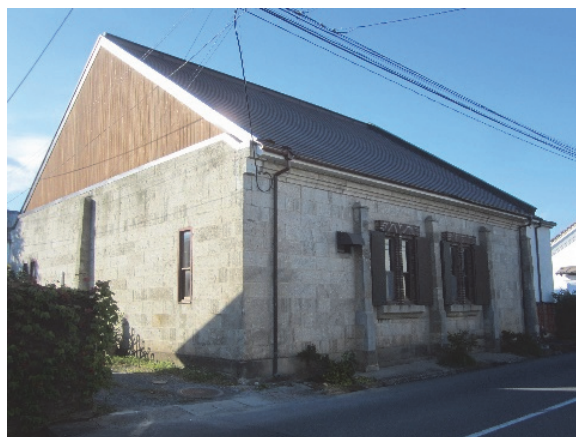
Former rice storing and milling house (board wall repairs)

the collapsed gable wall was later repaired by replacing it with a board wall. The building was closed after the disaster, but it is currently being renovated to be used as a *sake* brewery. For the process, reinforcements with RC foundations and steel frames are underway.

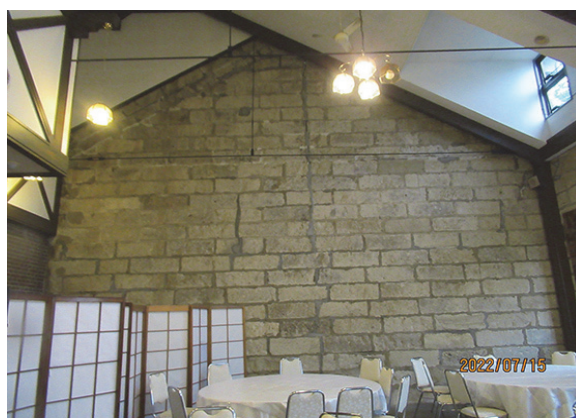
The repeated crack damages by the February 16, 2022, the Earthquake off the coast of Fukushima Prefecture (Former rice storing and milling house)

Cracks appeared in the (unreinforced) stone constructions after the Great East Japan Earthquake. The cracks were later repaired, but they were damaged again by the Earthquake off the coast of Fukushima Prefecture in 2022. In addition to being used as a restaurant, the building was the site of a symposium in the fall in 2011.

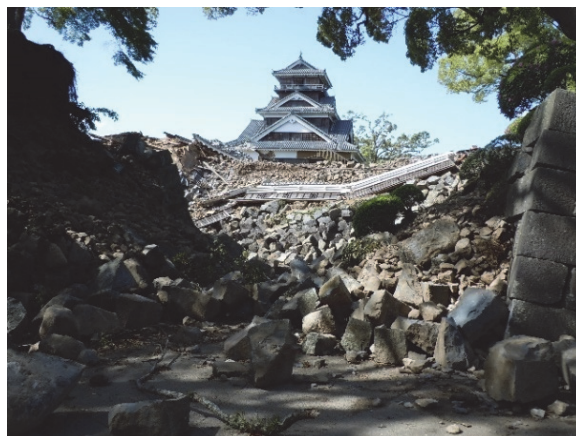
Kumamoto Castle has 973 stone wall segments covering approximately 79,000 m². Of these, 229 segments, or approximately 8,200 m² collapsed due to the earthquake, which is approximately 10% of the total area. If we add the areas that were assumed to require partial repair due to loosening or bulging, we will get 517 segments or approximately 23,600 m², which is approximately 30% of the total area. Naturally, the damage figures will fluctuate as the recovery project progresses, but fortunately, there have been almost no secondary collapses due to aftershocks. On the day after the foreshock, aftershocks were still severe, and the staff was scattered at emergency posts, such as evacuation centers, so the initial survey was limited to a brief preliminary level; then the main shock occurred before a full-scale assessment could be conducted.

Damage to stone walls

The conservation of the stone walls, except for the Tenshukaku castle towers or donjon and the Iidamaru-Gokai-yagura turret, is being carried out with priority given to the stone walls of the buildings with Important Cultural Property status. The stone walls of the donjon have already been re-stacked, and the stone walls of the Iidamaru-Gokai-yagura turret are currently in the process of re-stacking. On the other hand, there are many areas where the primary work has been completed,

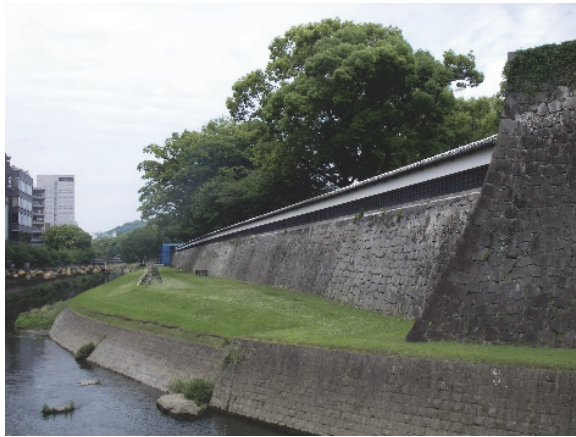
After completion of restoration work of the Nagabei wall

to have been reconstructed by the Japanese Army. The western half was tilted by a typhoon in 2015, and the eastern part collapsed by the 2016 earthquake and was completely dismantled as part of the recovery process. The stone walls were not severely damaged and were not repaired. The damaged supporting stone pillars were also repaired, and an archaeological excavation of the foundations was carried out. Stainless steel braces were newly installed as seismic reinforcement. Repairs were completed in January 2021 with a subsidy from the Agency for Cultural Affairs (Important Cultural Properties Repair Project, Disaster Prevention, and Presentation Adaptive Reuse Project).

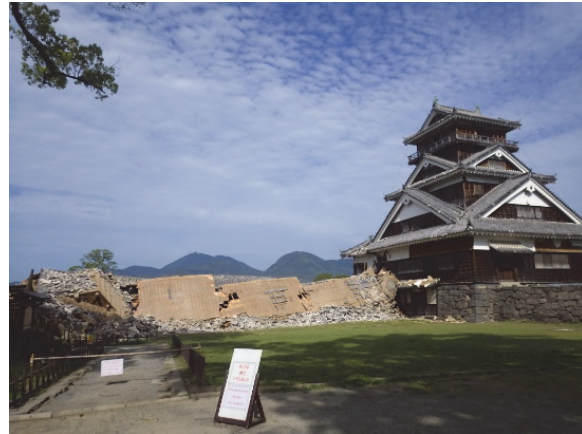
It consists of a five-story turret and Tsuzuki-yagura or continuation turret built at the northwest corner of the central compound. The Tsuzuki-yagura turret collapsed along with the inner stone wall. The fence also suffered significant collapse along with the stone wall. The turret and fence were recovered, as well as the collapsed stone wall. The stone wall under the Gokai-yagura turret (five-story turret) was not seriously damaged, but it was deemed necessary to repair the turret with full-scale dismantlement and reassembly of original structures due to damage such as the tilting and uneven settling of the building and the broken posts. The high stone walls are currently undergoing a study of their conservation, and work on the Gokai-yagura turret is ready for dismantlement having a covered protecting awning since 2022. Funding is provided by a subsidy from the Agency

The Uto-yagura turret after the earthquake

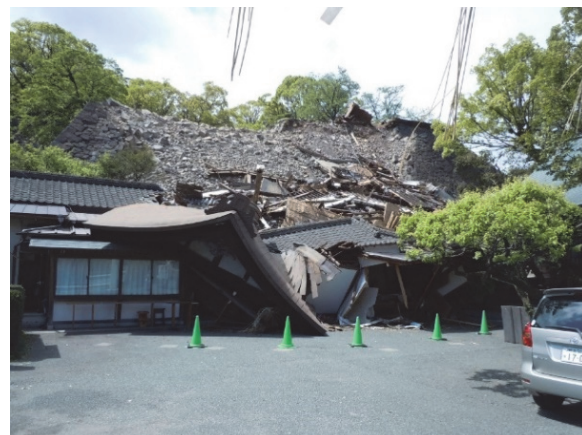
Single-story turrets line the northeast side of the East Takenomaru. Higashi-Juhachiken-yagura turret and Kita-Juhachiken-yagura turret suffered major collapses of the stone walls of their foundations, followed by the collapse of the buildings. Goken-yagura turret escaped collapse, but its walls and posts were severely damaged and tilted. The funds are being provided by Agency for Cultural Affairs subsidies (for Important Cultural Properties repair projects, disaster prevention, and presentation adaptive use, as well as for the "History in Motion!" Comprehensive Rehabilitation of Historic Sites).

Damage to the Higashi-Juhachiken-yagura turret by the earthquake

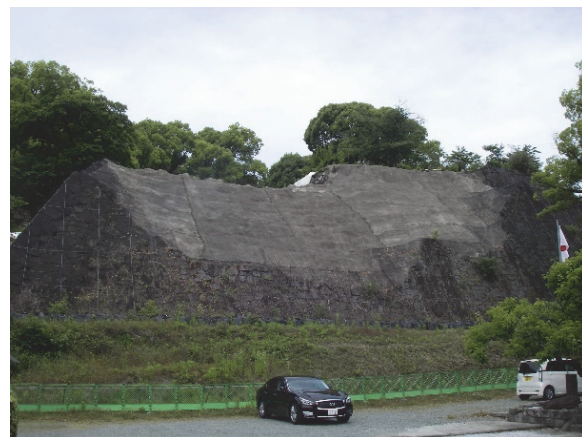
Stone wall of the Higashi-Juhachiken-yagura turret (after dismantling)

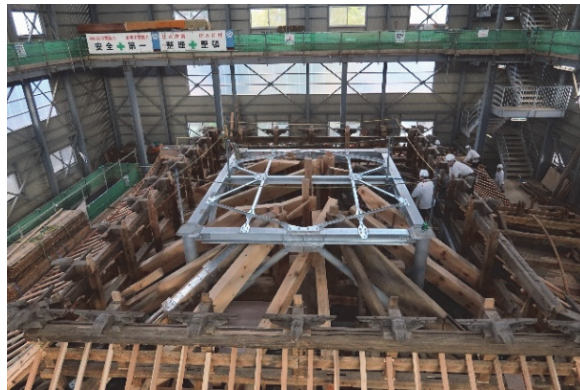
Seismic reinforcement plan of the tower gate

Steel Seismic Reinforcement Frames and Dampers, Tower Gate interior

the original structures, perform partial repairs on all damaged parts of the other gates, and provide necessary retrofit to ensure seismic reinforcement to withstand a seismic intensity scale equivalent to that of the main shock. The overall construction process is as follows: from FY2016 to FY2018, the Tower Gate was to be dismantled, stored, and investigated, and restoration with complete dismantlement and reassembly of the original structure (Phase 1) was to be carried out. Assembly work on the Tower Gate began in FY2019 and is still in progress, with completion scheduled for FY2023.

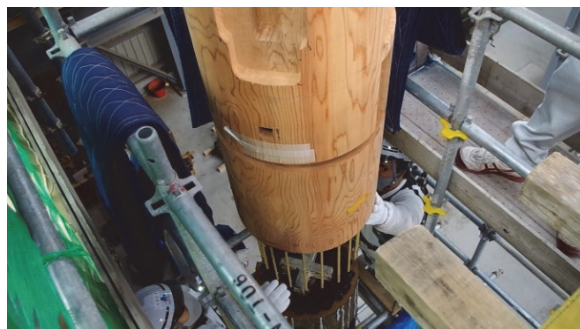
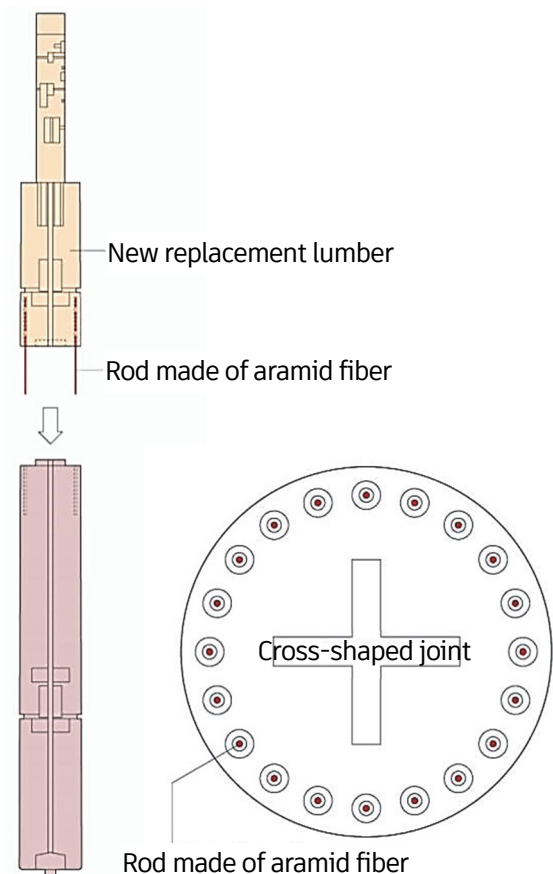
Joints at the top of the posts using aramid rods

Schematic diagram of the joints at the top of the gate columns using Aramid rods

Seismic reinforcement of the shrine was performed by installing wooden braces under the floor to ensure seismic resistance performance. The collapsed Tower Gate was repaired by a new method using rods made of aramid fiber, used for the first time for repairs to wooden constructions of cultural property buildings. The motivation was to reuse broken posts and corner rafters as much as possible. In the process of repairing the building, a large number of old ink writings were discovered on the original building materials, revealing the names of the carpenters involved in its construction, their hometowns, and the places where the lumber was produced. As for social inclusion and contribution efforts, the shrine invited local high school and university students in the field of architecture to pro-

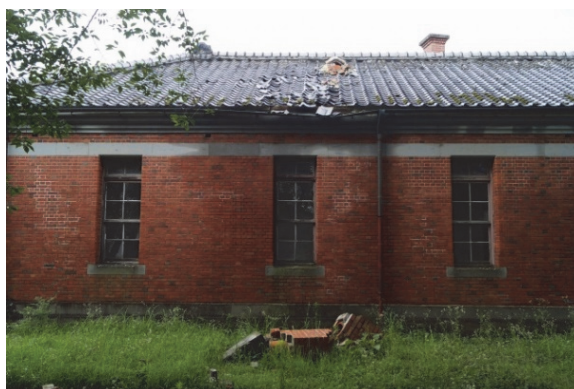
Chemical Laboratory, the broken and fallen chimney

Common damage to these four buildings in the Kumamoto Earthquake were cracks and misalignment of the frames. In (#1), (#2), and (#4), the cracks can be observed entering at 45 degrees from the corners of the openings. In (#1), a large crack appeared at the junction between the interior wall dividing the classrooms and the exterior wall in the east-west direction. In (#4), at the height of the window sill, both the upper and the lower structures were cut and displaced. Additionally, it appears that the east-west gable wall might have been severed from the north-south wall at some point and subsequently resettled, particularly noticeable towards the top section. In (#1) and (#2), where the chimneys are located, there is evidence of chimney breakage on the roof surface, and a broken chimney causing damage to the roof. In (#1) and (#2), the arches above the corridor were also cracked. The second floor of (#1) was particularly badly damaged, with the lime plaster of the arch falling and some of the brickwork collapsing. In addition, in (#4), part of the roof truss was detached, and some of the surrounding timbers were damaged.

After the damage caused by the Kumamoto Earthquake in April 14 and 16, 2016, emergency response work included chimney removal (November of the same year), temporary reinforcement of (#4) (completed in October 2017), temporary reinforcement of (#1) and (#2) (completed in March 2018), followed by permanent recovery of (#3) in March 2018, the same work on (#1) and (#2) in December

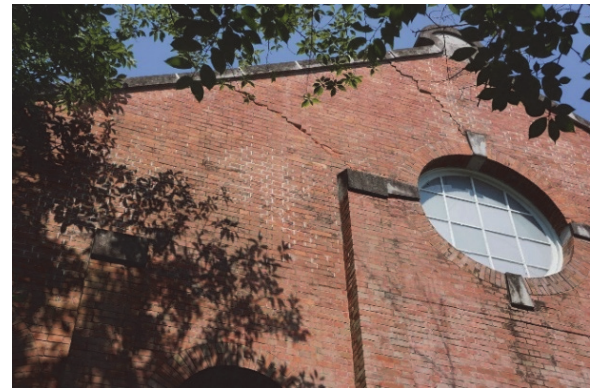
The Experimental Factory for Mechanical Engineering, cracks entering at an angle from the round window in the gable wall

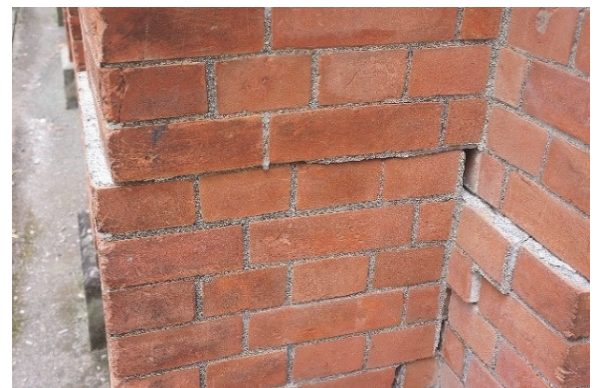
The experimental factory for mechanical engineering, displacement of the brick pillar

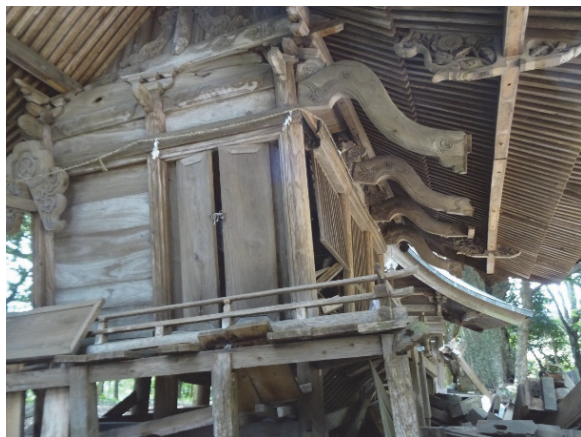
Damage right after the earthquake:
Hachio-sha Shrine main frame

Nishihara Village was severely damaged by the Kumamoto Earthquake, as the epicenter of the earthquake was located along the Futagawa fault, which passed through the village. Although the damage due to age was relatively minor, the extensive destruction can be attributed to structural flaws resulting from the unstable foundation and platform construction method along with the 1952 roof alteration. The raised platform was structurally unstable, and many of the foundation stones toppled over, causing the shafts to become severely unbalanced. The frame of the roofed porch collapsed and the building center tilted sharply to the north. All three main posts on the north face were broken at the points where they intersected with the penetrating tie beams and were on the verge of collapse. In addition, the roof trusses were pushed up by the vertical shaking and shifted, and the eccentricity of the roof load exacerbated the damage condition. Worship Hall and Hall for Offerings suffered complete collapse.

The restoration plan determined that the main shrine of Hachio-sha Shrine, Worship Hall, and their foundation would undergo a full scale dismantlement and reassembly of original structures.

The main shrine foundation and platform were reinforced, and the framework was repaired without using excessive structural reinforcement to ensure that the members were firmly connected to each other, in accordance with traditional construction methods and specifications. Since the roof trusses were structurally deficient with huge cantilever beams, the truss was reconfigured with introduction of such structural elements such as *doi* girders, struts, and corner cantilevers. The reuse rate of the original wood was 80%. Amamiya Shrine was re-erected and partially repaired.

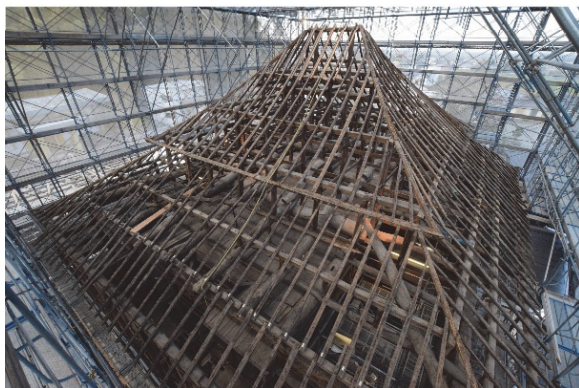
Roof dismantlement in progress, Kaijo-ji the main hall, view from the northeast

Kaijoji Temple is located on the north side of the Futagawa fault line. This area is estimated to have fluctuated up to 1 m to the east and sunk up to 1 m or more after the earthquake. There were cracks right in the temple precinct, indicating that the building experienced significant shaking. Damages to the main building were mainly around the roofed porch and the *shikoro* roof tier. The roofed porch and columns were tilted forward. Around the *shikoro* roof tiers, rafter-ends were detached from the struts due to the failure of the intersecting purlins that either got crashed at the corners or broken in the area between the two roof tiers. In addition, the

Drafting of the implementation plan began in June 2018, and the repair work began in June 2019 and has been completed by the end of December 2021. The main hall was repaired with partial dismantlement and reassembly of original structures due to partial damage to most of its components, while the components of the roofed porch, mud walls, and failed roof tiles had already been removed during the emergency work. In principle, the building was restored to its pre-disaster appearance, but some modification were introduced in the restoration process. These included restoration of the outer sanctum and open veranda, replacement of aluminum sashes with wooden fixtures and fittings, and restoration of the pantiles of the main roof. Seismic reinforcement was also carried out. As a result of seismic reinforcement assessment, some of the walls were converted into seismic re-

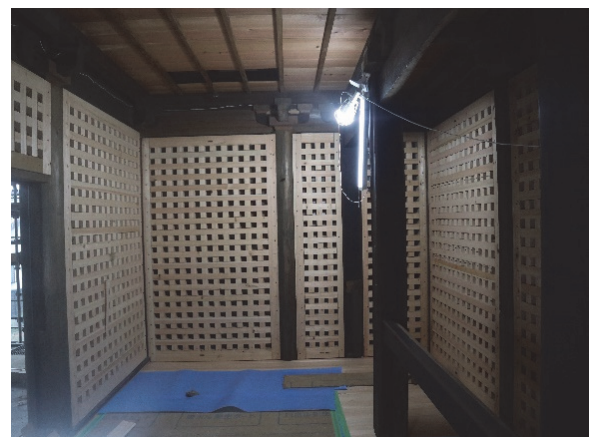
Reinforcement latticed walls over the floor

c. Seismic rings: To improve longitudinal restorative capacity, 8 rings are to be installed on the 4 front and rear center columns and on the floor and foundation beams.

d. Ace line ropes: the columns were tied to the concrete foundations at six locations to prevent them from slipping and falling off the foundation stones.

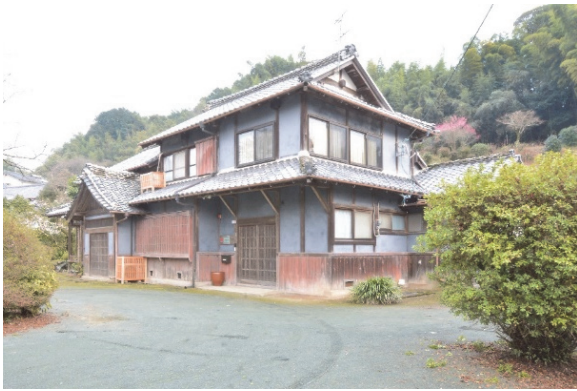
Overall view after completion of restoration work

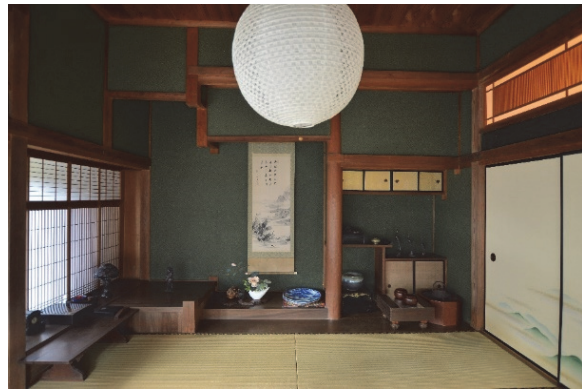
Repair of the alcove area after the restoration

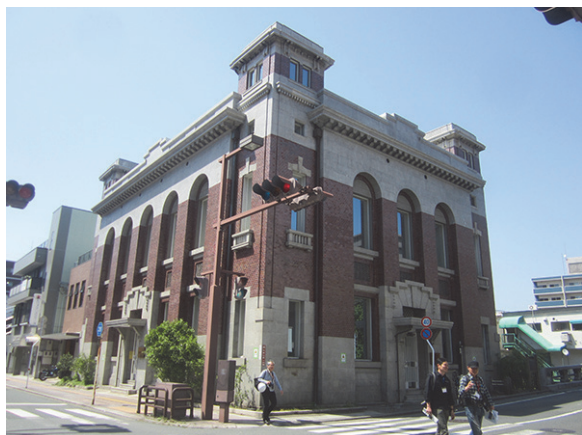
Overall view of the building

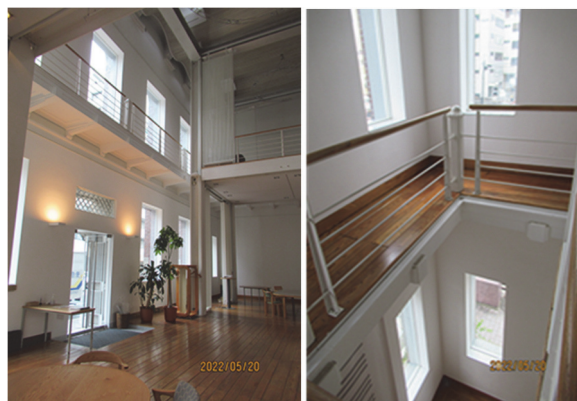
After restoration view

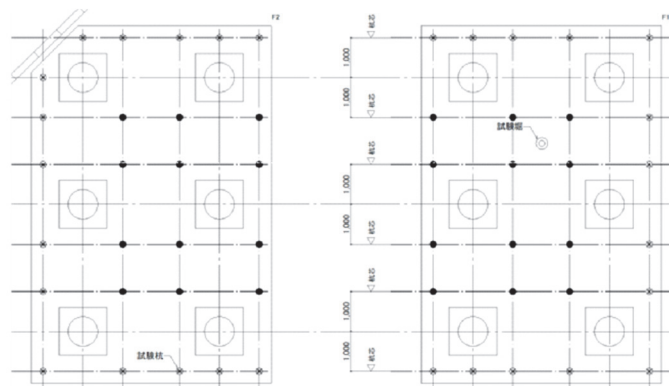
Layout of the added RC footings and steel pipe piles (Prepared by Den Arch.& Eng. Office)

After reviewing the results of the seismic assessment of the building and the seismic ret-rofit plan, reinforcement and maintenance work was carried out on the building frame, focusing on the changes described on the layout shown on the right. [Gable side: south and north] [Flat side: east and west] Reinforced concrete walls were added to the upper part of the beams (with some openings). [Center, X direction] Reinforced concrete walls were added between Y2 and Y3 on X2 and X3 lines (with partial openings). [Center, Y direction] Reinforced concrete walls were added between X1 and X2 and between X3 and X4 on Y2 lines. [Ceiling SL floor] Reinforced concrete beams were added on X2, X3, and Y2 lines. [Foundation] 53 steel pipe piles were added. Re-inforced concrete footings were added to the gate, surrounding 6 columns on each side of the gate.

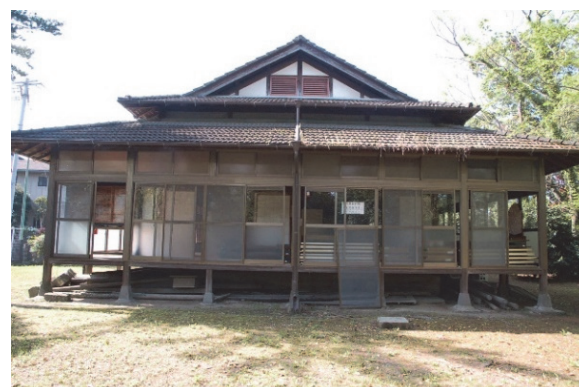
Overall view after the earthquake (the building was not so rigid that the shaking did not dislodge the foundation strut stones)

walls fell, but they were among the elements that were expected to be repaired. The outer columns were on strut foundations, but their low rigidity paid off: they shook so much that they did not displace from the underfoot, and no columns were stepped off. Instead, the walls, fixtures and fittings were severely damaged.

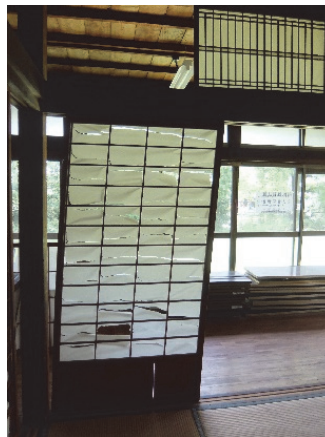
Estimated to have shaken up to $1/12$ radian based on residual deformation of the shoji

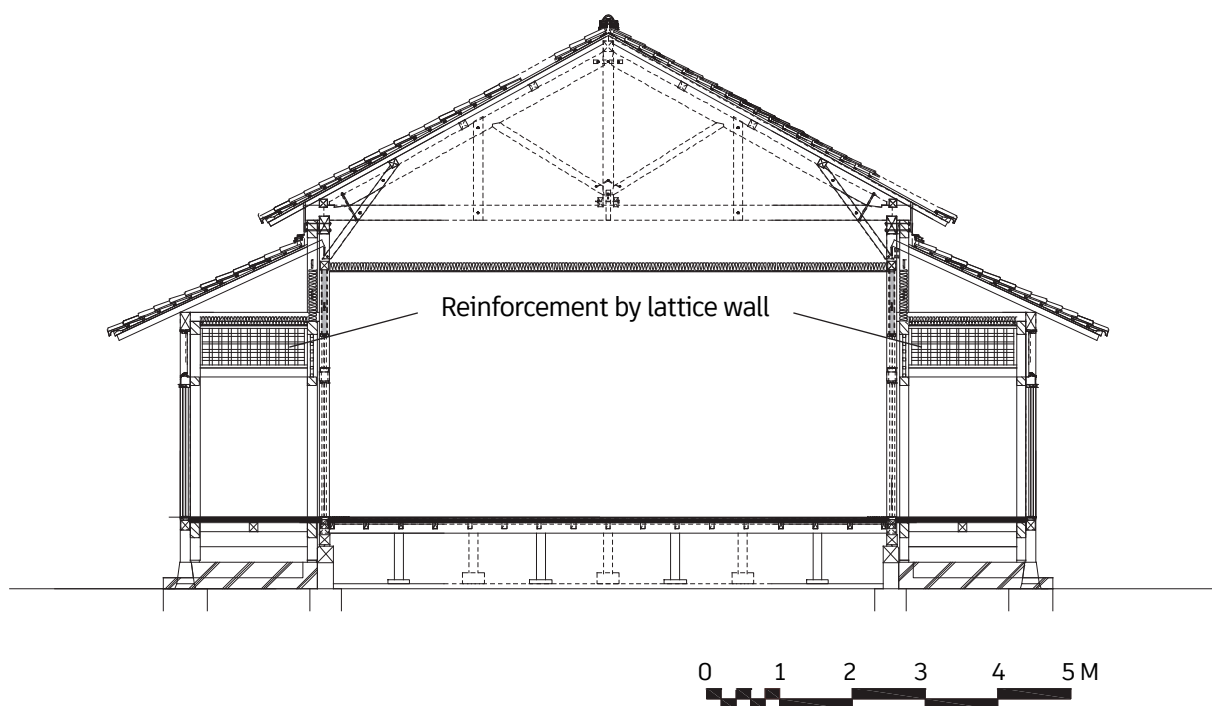
Outline of seismic reinforcement plan

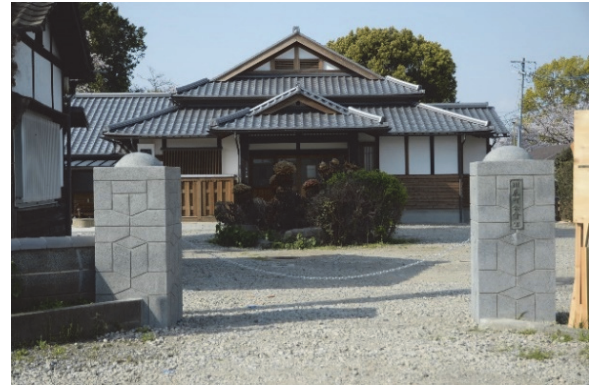
Overall view after restoration

- (2) Three sides of the building have full-opening glass doors, which were equipped with storm doors. It is difficult for a single management person to maintain opening and closing the storm doors every day. If the glass pane of the glass doors is thickened and divided into small

sections, even if the glass is damaged by a typhoon, the damage will be limited and can be easily handled by non-professionals with the use of boards, etc.

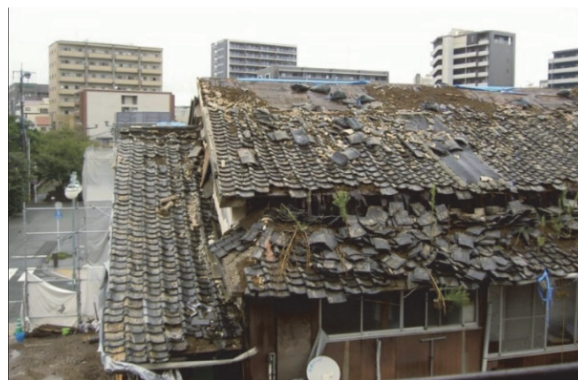
Immediately after the Kumamoto Earthquake, by visual inspection of the exterior conducted by the Post-Earthquake Temporary Risk Evaluation Rating gave the building a rating of "Red," and the disaster certificate stated "complete destruction". In addition to the roof tiles and mud walls breaking, the 4-ken wide building on the west side (tenement house), which was built in 1877 and later purchased by the Kiyonagas, was also in great danger of collapsing as columns were tilted and beams were missing. The fallen roof tiles caused severe leaks, and on the day after the rain stopped the roof was covered with plastic sheets, replacing the protecting sheets while the mud walls continued to crumble. Water was pumped out of the water collection vats installed.

Damage to the main roof

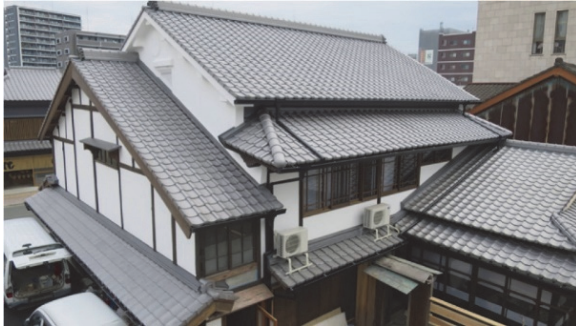
After completing the restoration of the main roof

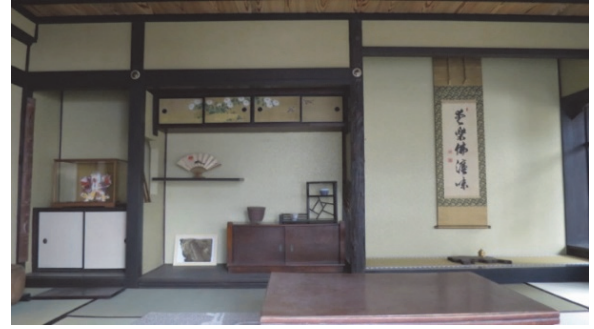
After completing the restoration of the reception room in the first floor

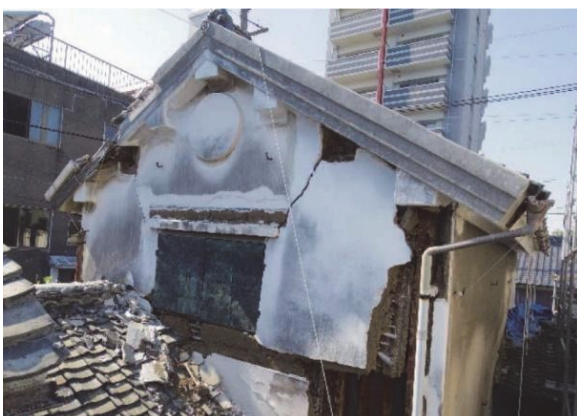
mantling of a neighboring house. Most of the damage was caused by collapsed roof tiles and lime plaster walls as well as tilted buildings due to the deformed shafts, fixtures, fittings, and crushed parts that were damaged by ants. The subsequent rainfalls caused leaks that facilitated widespread mold growth, progressively damaging houses and household goods. At that point, the damage was within the range of possible conservation if viewed on a building-by-building basis. However, when viewed on a 13-building basis, the required cost and energy were expected to be enormous, and the owners considered dismantling the houses, only leaving some parts standing.

The warehouse (south side) immediately after the Kumamoto Earthquake

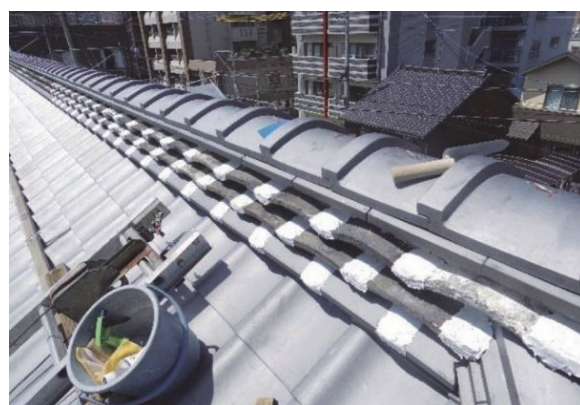
Restoration of the main ridge (main building) using the original "*noshi*" roof tiles

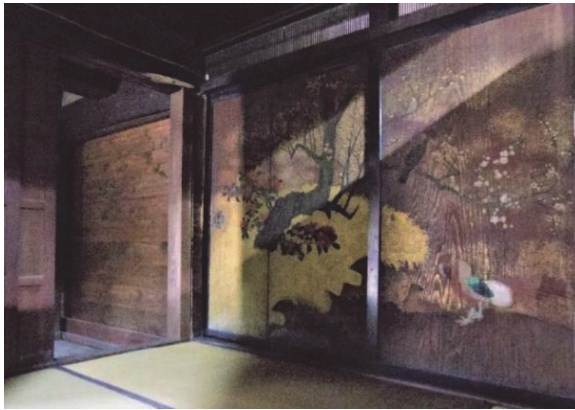
Installed cedar plank earthquake-reinforced walls (left side of the board door)

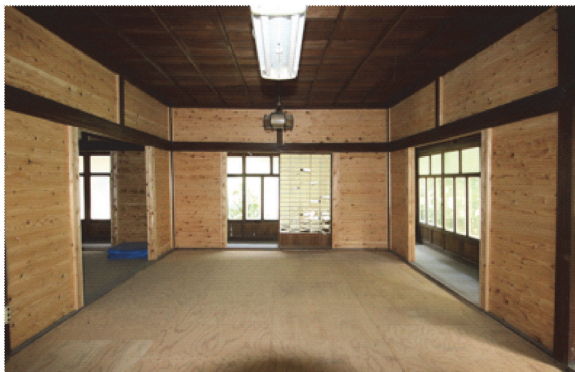
Additional cedar plank earthquake-reinforced walls in the study room

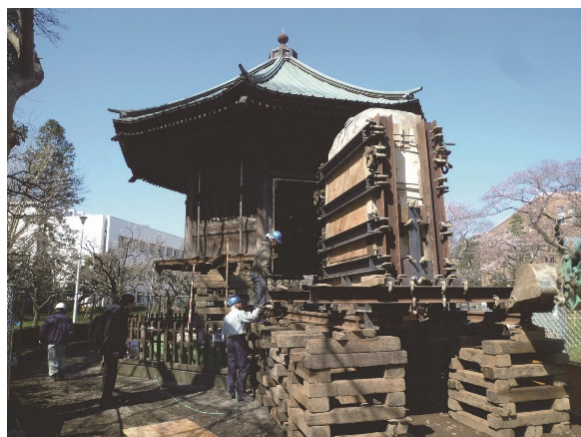
The body of the monument was lifted and moved on rails

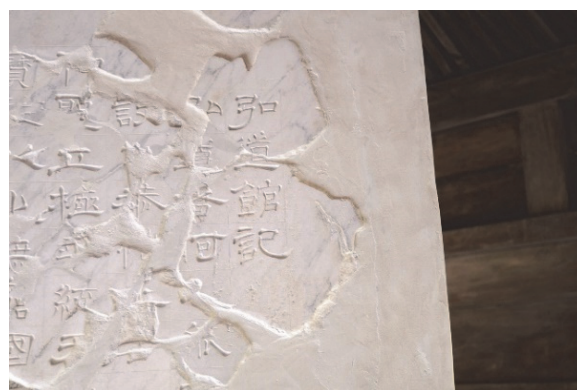
Restored inscription surface of the Stone Monument of Kodokan

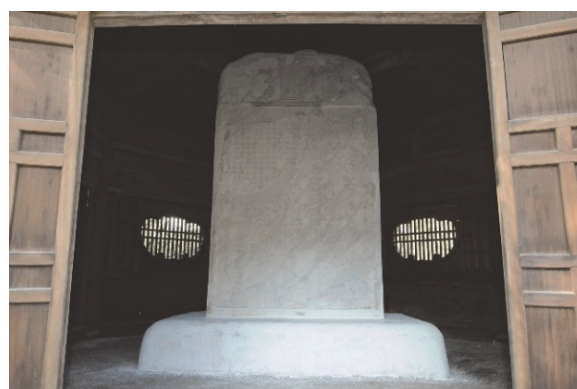
Conservation work of the Stone Monument of Kodokan was completed so that its appearance was closer to the original than the appearance the monument had before the earthquake.
