EARTHQUAKE DISASTER PREVENTION OF CULTURAL HERITAGES - EXPERIENCE AND DEVELOPMENT IN JAPAN -

**August, 2023
ICOMOS Japan**

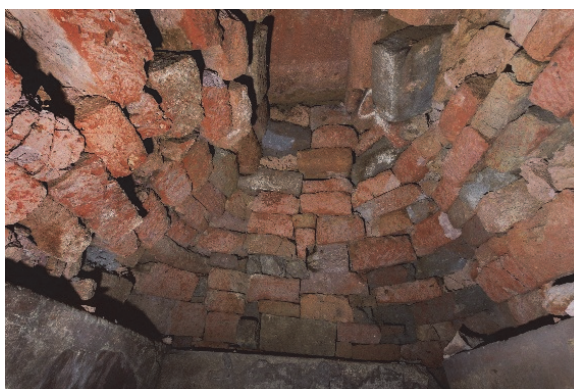
Located on the Futagawa fault zone, the site is close to the epicenter of the main shock, which registered a seismic intensity of upper 6. As a result, numerous cracks were found in the mound, and the stone chamber, including the stone barrier on the back wall, suffered extensive damage, with stones cracking and falling off.

Damage inside the chamber (Photo provided by Kashima Town)

Since the mound cracks could cause a landslide, emergency measures to prevent the mound from collapsing were carried out in 2021. As a result, the slope of the mound, which had been irregularly shaped for some time, was reinforced with retaining walls. The conditions inside the mound have not changed since FY1991, when the antechamber and pathway were reinforced, and there is no prospect for recovery due to the difficulty of researching safety measures for working inside the mound. The *History in Motion!* fund is providing the funds for the recovery work.

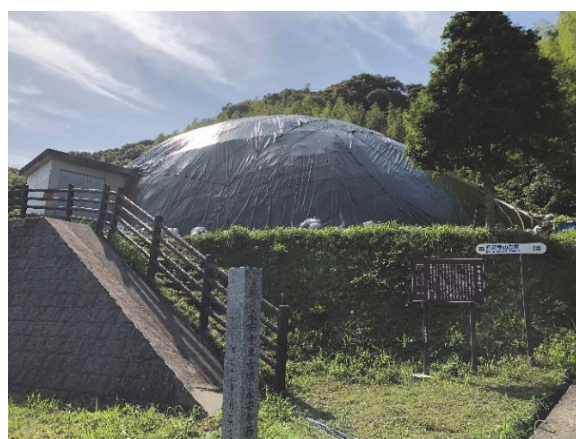
Part of the mound collapsed due to the earthquake, and earth and sand covered the floor of the ante-chamber and corridors. In addition, part of the stone materials of the chamber collapsed. The dome of the protection facility is cracked and the foundation is damaged.

The Eianji-nishi Ancient Burial mound has significant microbial contamination throughout the entire protection facility. The entire mound was covered with a dome for presentation, but the dome itself is also damaged. Since the interior en-

Exterior view of the mound, from the east
(Photo provided by Tamana City)

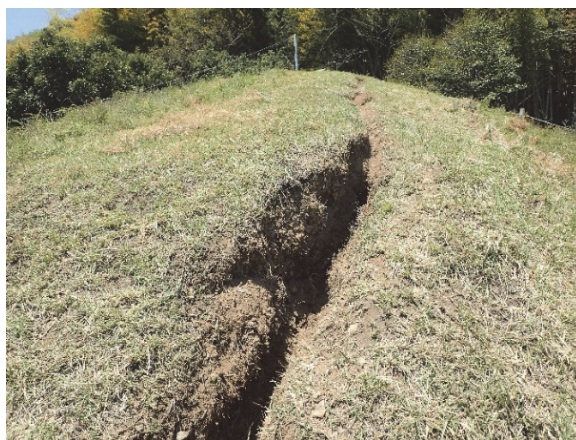
The earthquake caused damage to the stone chamber: some of the stone materials broke and a part of the decorated walls collapsed. The broken and fallen stones caused earth and sand to flow in. In addition, water leaked into the stone chamber from a crack in the mound that underwent maintenance.

Cracks in the mound
(Photo provided by Tamana City)

The decorated chamber walls are damaged and must be carefully restored so as not to damage the painted chamber walls. The damaged stones are to be kept in the stone chamber without forcibly joining them. The damage in the stone chamber is to be assessed from various angles by comparing the results of a laser survey and the drawings at the time of initial maintenance work. Then, after understanding the characteristics of the stone materials and the current environment, measures inside the stone chamber will have to be considered to prevent further weathering, dew condensation, and damage to the stone material. For the mound, geological surveys such as boring, radar exploration, and electrical exploration were conducted in 2020. Based on the results of the water leakage monitoring and of the geological survey, the cause of the leaks in the stone chamber will be identified, and a

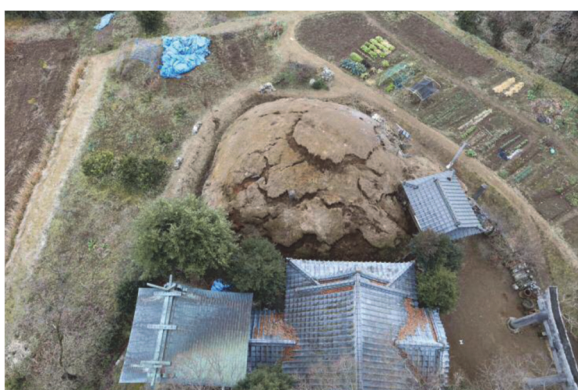
the corridor collapsed, the side wall of the front chamber was knocked off, and the stone blocks of the main burial chamber cracked and fell off.

Damage to the mound (Photo provided by Kumamoto City)

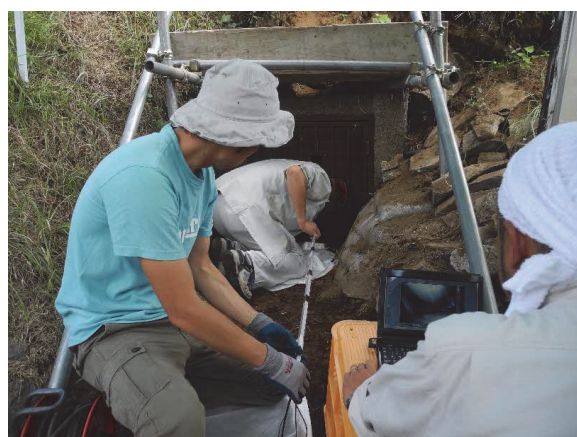
Survey of the interior of the stone chamber using a small camera (Photo provided by Kumamoto City)

Since it was impossible to enter the stone chamber when it was first damaged, a damage assessment of the stone chamber was conducted with the assistance of the Nara National Research Institute for Cultural Properties using a small camera. This allowed us to gain a better perspective for subsequent projects.

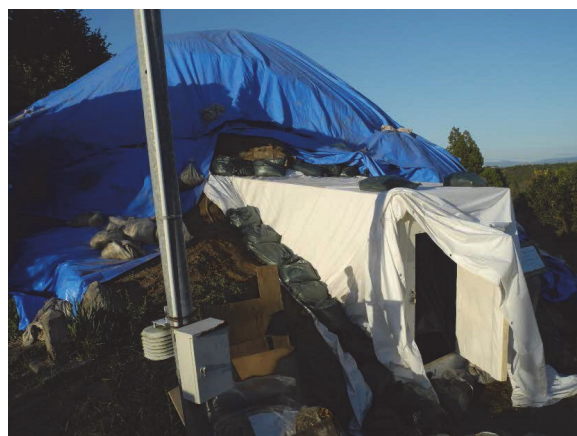
Installation of a windbreak chamber (Photo provided by Kumamoto City)

Because it is a burial mound with decorated chamber walls, the disaster recovery project pays close attention to the fluctuating environment. As regular measures, we are monitoring the temperature and humidity, monitoring the moisture of the mound, installing a windbreak room, and curing the mound with water-permeable anti-grass sheets. During excavation, we cure the concrete dome with insulation, prevent rainwater inflow with plastic sheets, and reduce the impact of outside air inflow.

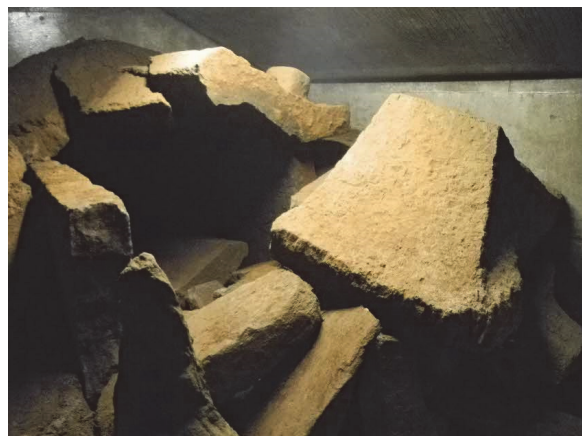
The side walls of the stone coffin collapsed due to the earthquake, and the ceiling stone fell and

was severely damaged. Since the stone coffin is located inside the preservation facility, it is believed

The damaged stone coffin
(Photo provided by Kumamoto City)

After surveying the mound and measuring the stone coffin, recovery methods were investigated. An issue was the difficulty of conducting conservation repairs due to the lack of space in the preservation facility. Mound surveys and excavations were conducted to determine the conditions of the Sandanzuka, Kunugizuka, Biwazuka, and Ryuganzuka tumuli, confirming that the damage was limited to the reconstructed mounds. Regarding the recovery for the Kunugizuka tumulus, the mound scraped as little as possible, and the slope was protected with large sandbags and blocks. For the Sandanzuka, Biwazuka, and Ryuganzuka tumuli the mound soil that had been maintained was restored.

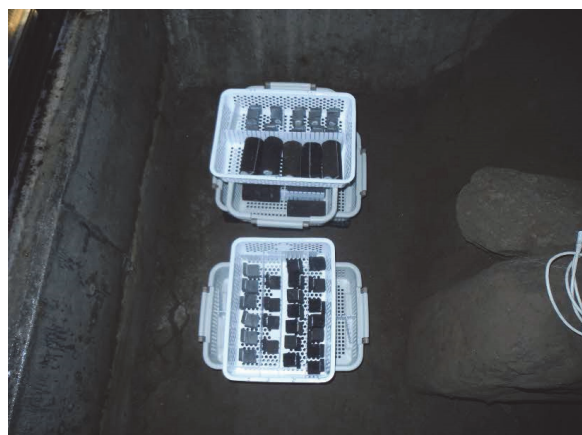
Adhesive weathering tests
(Photo provided by Kumamoto City)

Since the collapsed house-shaped stone coffin is the main target for recovery, continuous research is being conducted to select an adhesive that does not affect the red pigment while maintaining sufficient adhesive strength. Research is also being conducted on the method of adhesion, and on alternative materials for the crushed stones. A recovery method for the stone coffin will be selected based on the results of this research. An environmental survey is also being conducted to ensure that the surface of the stone with line engravings will not deteriorate.

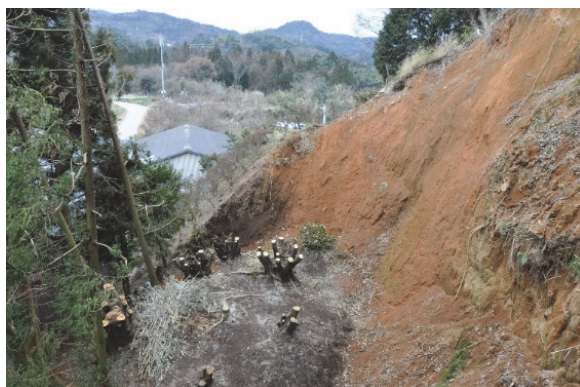
Collapsed soil in the back circle section (from the east) (Photo provided by Uto City)

intervention to the mound was particularly prominent at the front tip and the south-side circular back, and the slope of the mound rose up at a very steep angle even before the earthquake.

As of FY2022, the damaged area will be divided into three construction zones for the planned disaster recovery work: i, one for the back and two for the front part. Normally, it would be best to reconstruct the mound and return the slope to the original angle of inclination, but there is no space around the mound to do so. Therefore, in order to stabilize the mound even if the slope remains steep to some extent, the most appropriate construction method will be selected for each site, using reinforced mud walls, long-fiber reinforced earthwork, and large block retaining walls in addition to embankment. This is only a plan, and the final method to be used has not yet been decided.

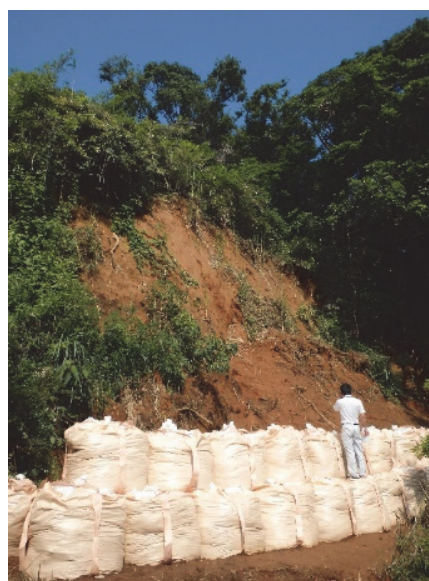
Large sandbags in the front part (from the southeast) (Photo provided by Uto City)

In the front, a nearby warehouse was dismantled to allow the entry of heavy equipment to remove the collapsed soil. Emergency treatments were then carried out by installing large sandbags to hold the soil in place. In the back, part of the mound slid down in a lump along with a tree. The trees at the bottom caught the mound and there was no damage to the adjacent buildings. In a part of the remaining section of the mound, white clay-like soil, different from the surrounding area, was found, and it is thought to be an exposed part of the grave pit associated with the main mound. In addition, several cracks are still visible around the collapsed area, including large cracks with dozens of centimeters wide and deep. In addition, as of 2022, small-scale collapses and soil runoff continue to occur around the collapsed site and the site remains in unsafe conditions. The damaged areas were covered with plastic sheets for protection.
