The Kumamoto Earthquake

Report on the Damage
to the Cultural Heritage

1 December 2017

Japan ICOMOS National Committee

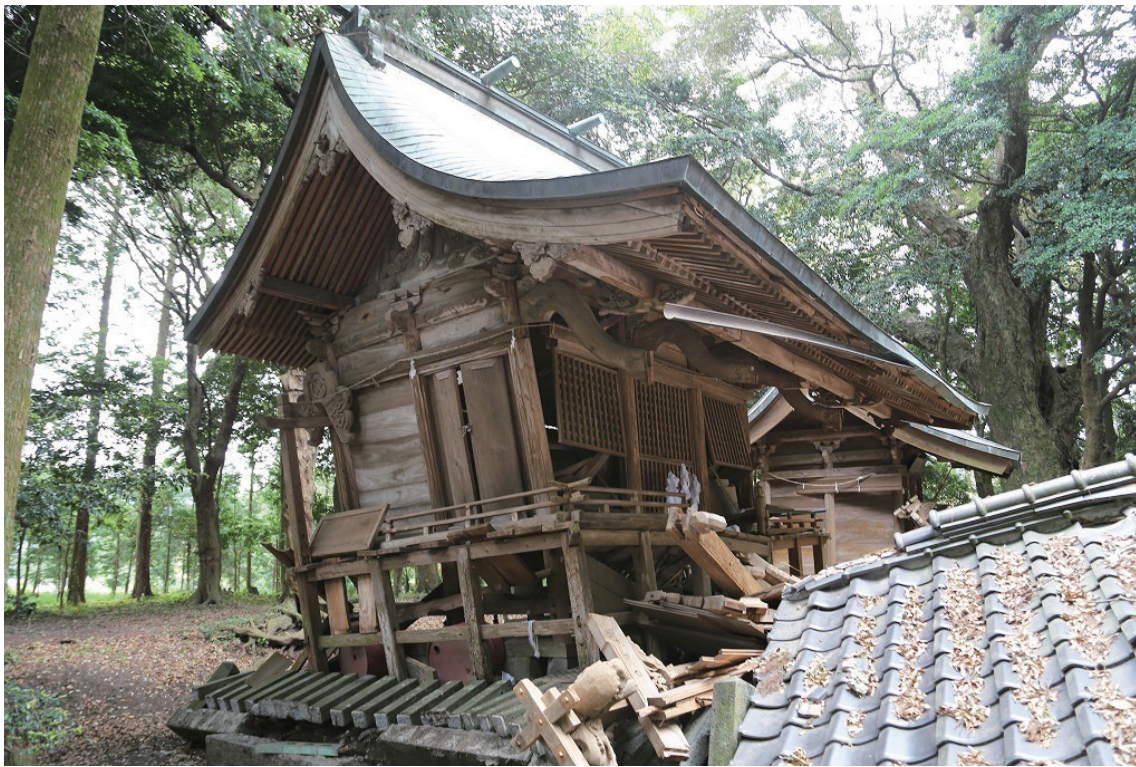
A huge sloping the main hall and collapsed the worship hall, Hachiosha Shrine

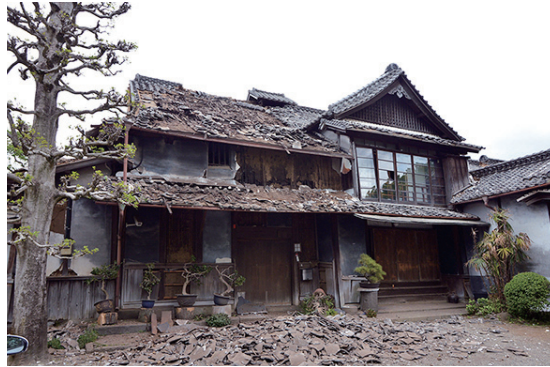
earth walls of the central storehouse. Effects of the main-shock earthquake extended to the main building: the building inclined up to more than 1/8 towards the west side, roof tiles and earth walls fell down. As for the interior, parts of the ceiling above the large room (*hiroma*) fell, the reception room (*zashiki*) inclined towards the south, and the walls attached to the alcove were damaged. In terms of structure, the main building is divided into three buildings: one centered on the earth floor *doma*, another on the south side centered on the *zashiki* reception room, and another comparatively new one to the north side; it is the connections between these buildings that broke, with fractures up to some 50cm where large. The stable's west side outer wall fell and the building inclined greatly towards the road on the west side. At the central storehouse, the pillars came off their foundation stones and the structural frame inclined towards the west side. Also, most of the earth walls fell. The rear gate collapsed onto the road on the west side. Protrusions occurred at parts of the stone wall on the north side of the site. The Eto family home is located to the northeast of the Futagawa River fault, which was the epicenter of the main-shock earthquake. The main building and other buildings on the site inclined to the west side or the west-southwest side due to the main-shock earthquake; this inclination shows a direction similar to the direction of displacement of the Futagawa River fault, which extends from east-northeast to west-southwest.

Photo 3.1.1.2 The main building (after the earthquakes)

As emergency response measure to prevent collapse, temporary reinforcements were installed to the main building's interior and exterior on the west side, which had acquired a significant incline. Also, because there were concerns that during the rainy season leakage from broken roofs into the interior of the building would seriously damage the pictures on the partition walls, these were removed as a priority and stored separately. The stable had greatly inclined

From now on, measures will aim at making the structural frame of the main building sound after completely dismantling the building's west part that was significantly damaged. There are plans to build back the buildings centered on the reception room and that on the north side. Additionally, diagnosis of seismic resistance will be carried out and measures to strengthen the earthquake-resistance performance will be taken. The structural frame of the central storehouse will be temporarily dismantled to carry out conservation and repair works. Restoration works will be carried out for the stable, the *nagayamon* gate, and the rear gate. Works are scheduled to last around 4 years (until fy2020) for the main building. Repair works of the central storehouse and the stable are expected to start in fy2019 and take 3 years, up to fy2021. After that, the plan is to continue work on the other structures, including the *nagayamon* gate, the rear gate, the hut, and the outer structure, until fy2022.

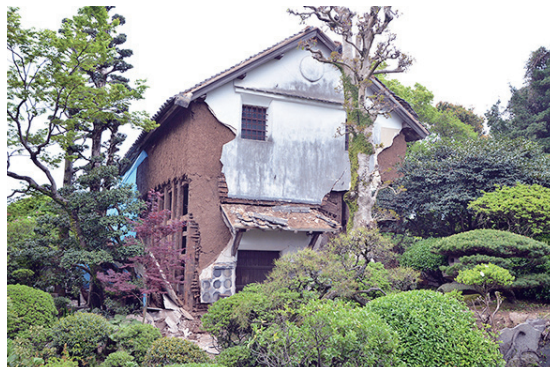
Damage in the fore-shock earthquake was limited to the collapse of the chimney on the north side of the main building and the partial collapse of the

Photo 3.1.1.4 The central storehouse (after the earthquakes)

towards the road side, up to as much as 1/8, and the deterioration of the bases of its pillars was also significant; it was temporarily dismantled for safety and preservation. At the central storehouse, the remaining earth walls were dismantled and removed, and temporary reinforcements were installed inside the building to control the incline. As for the stone wall, only sections with protrusions were dismantled, and the stones were put in storage.

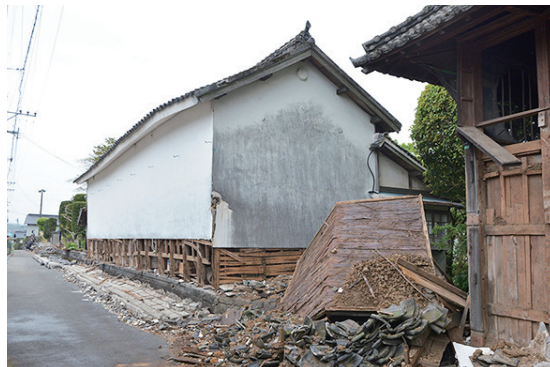
Photo 3.1.1.6 The stable (after the earthquakes)

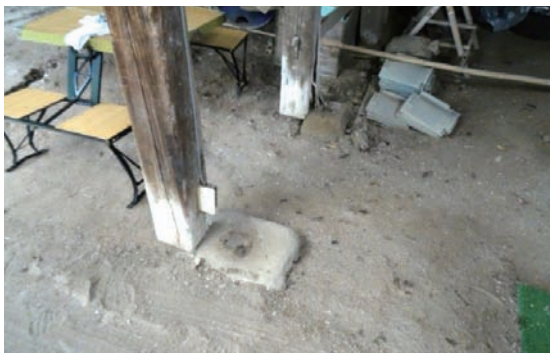
Photo 3.1.2.3 The shed pillars have come off their foundation stones at the Yano family home (*Hontaku*)

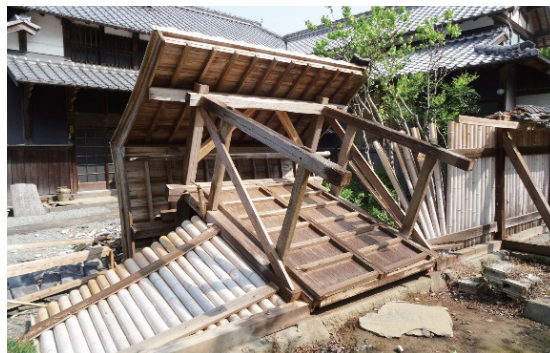
Photo 3.1.2.4 The middle gate collapsed at the Yano family home (*Hontaku*)

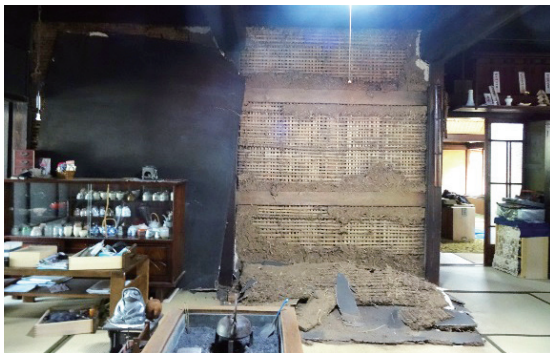
The tiled roof of the main building had been re-done prior to the earthquake, and survived the quake practically sound. However, the building sustained major damage such as the collapse of parts of the walls, and if one is to take into account those parts that have fissures, the majority of walls is not in sound condition. As for the structural frame, pillars are inclined in some parts, and in many places, they have come off the center of the foundation stones. Due to the fissure running under the main building, a dislocation appeared in the ground in the north-south direction, which caused various problems, such as the fall of the alcove lintel in the reception room and the dislocation of threshold members and head jambs.

Photo 3.1.2.5 The wall of the formal room collapsed at the main building of the Yano family home (*Hontaku*)

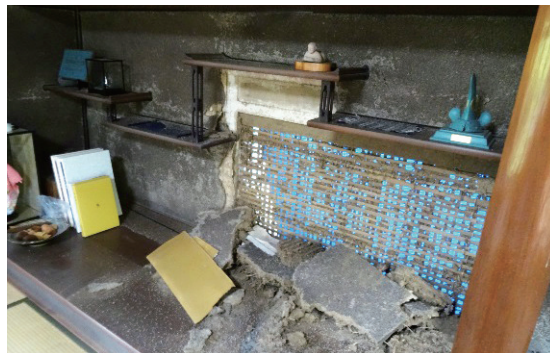
Photo 3.1.2.6 The wall of the reception room at the main building of the Yano family home (*Hontaku*)

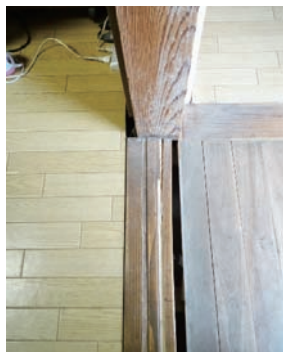
Photo 3.1.2.7 The thresholds have become misaligned at the main building of the Yano family home (*Hontaku*)

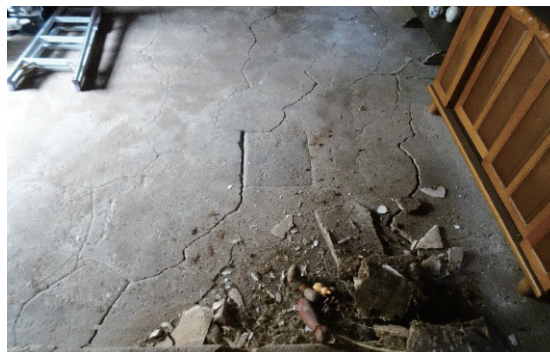
Photo 3.1.2.8 The fissure in the earthen floor of the main building of the Yano family home (*Hontaku*)

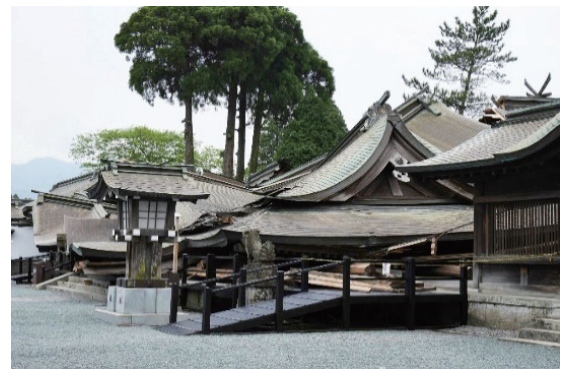
The Romon Gate, which was one of the Three Greatest Romon Gates of Japan, had an upper structure that was extremely impressive. The main-shock earthquake that struck the Aso region on April 16th registered a weak 6 on the Japanese seismic scale and the Romon Gate is considered to have collapsed due to the inclination of the columns caused by the tremors and the P-Δ effects resulting from the heavy weight of its upper part.

Photo 3.1.3.2 The collapsed Romon Gate of the Aso-jinja Shrine (inside the site).

The policy for the repair works of these buildings, which have been designated as Important Cultural Properties, is repair through dismantling for the Romon Gate and through partial dismantling for the other damaged buildings. The work began in Heisei 28 (2016) and is scheduled to continue until Heisei 35 (2023). (Photos 3.1.3.1-5 Taken by the author.)

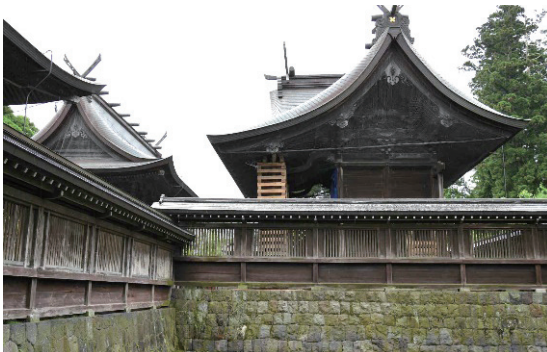
damaged in the recent main-shock earthquake. In addition, the Worship Hall within the precinct collapsed completely, and also the stone lanterns on the approach road collapsed.

Photo 3.1.3.3 The Worship Hall of the Aso-jinja Shrine was damaged.

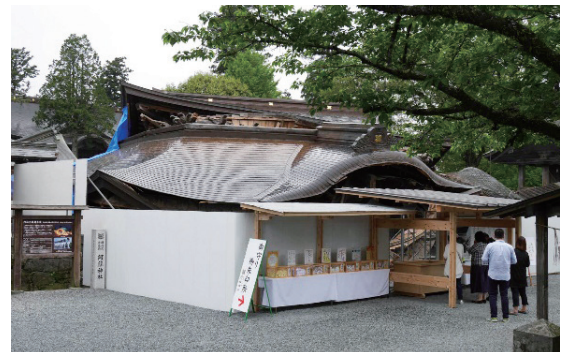
It was reported that, at the Kangyomon Gate and the Shinkomon Gate, some of the decorative parts fell down and there were some overall distortions. At the three sanctuaries, the damage to the San-no-shinden Shrine was the most severe, consisting of a deep inclination in the direction of the west cliff, and it has

been reported that the shrine is in danger of collapsing. The damage at the other two shrine buildings included the lifting up of some of the columns.

Photo 3.1.3.4 The emergency support at the San-no-shinden Shrine building in the Aso-jinja Shrine.

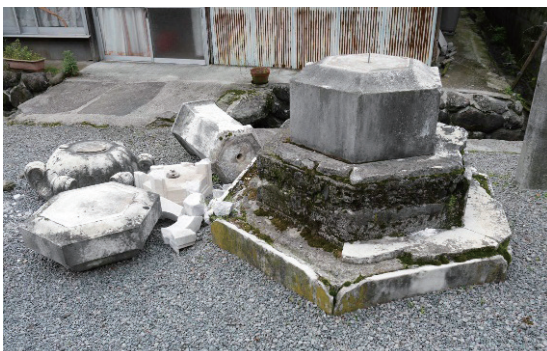
Photo 3.1.3.5 The collapsed stone lantern of the Aso-jinja Shrine.

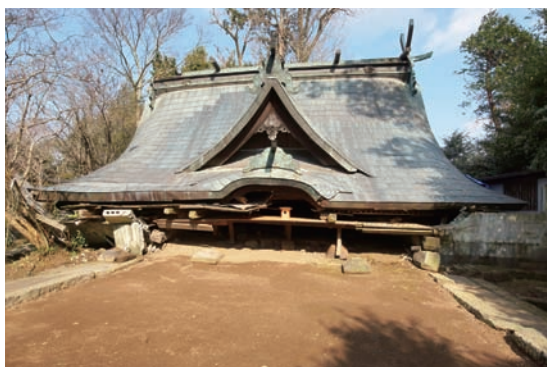
Kiyama shrine is located in the center of Mashiki town. It is officially called the "*Kiyama Kyuroku Kyuden Daimyoujin*" Shrine. Six generations of gods since Sun Goddess "*Amaterasu no Oomikami*" have been enshrined there. It has 19 subordinate shrines in Mashiki town and is worshipped as the central shrine "*Souchinju*" of the town. This shrine has been completely falling down by the earthquake, i.e.; main shrines, halls of worship, tower gates, Shinto shrine archway "*Torii*" and the lanterns on the shrine fence. None of these architectures have not been designated or registered as cultural assets. In spite of the strong local public opinions, there is no public fund aid so the prospect of preservation and re-construction still remains challenging. (Photos 3.1.5.1-3.1.5.2)

Photo 3.1.5.1 The remaining roof of worship hall of Kiyama Shrine after the earthquake.

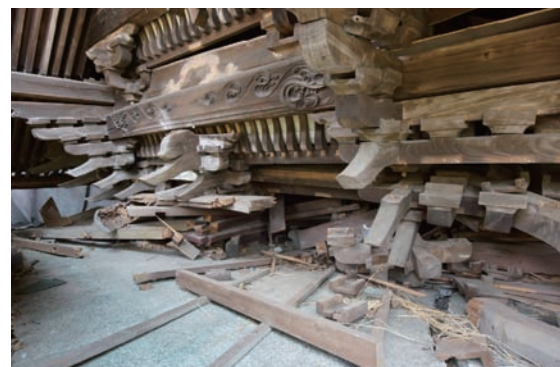
Photo 3.1.5.2 The decorated structural element which joins columns and the beams of a roof. (Sculpture of Horeki Era.)

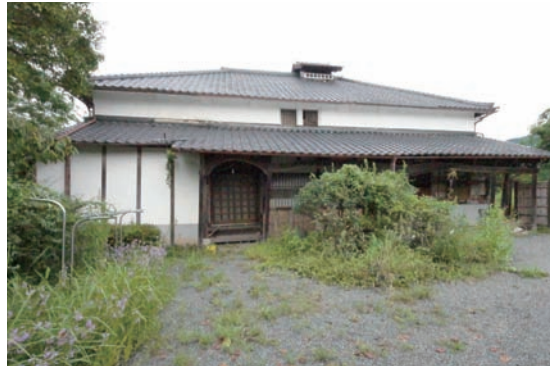
Photo 3.1.5.3 The Saionji family home

Due to the Kumamoto earthquakes, some of the columns and beams have been damaged and it appeared an incline of 1/5Rad. to west-northwest direction in maximum. It was barely avoid from collapse down.

The Footing of column which has been put on the traditional base stone was slipped on the stone base by the shock of the earthquake by about 40cm but safely remained. In contrast, at south part of the gate house, some columns of which has been coupled with reinforced concrete base foundation were cracked and about to falling down.

In case of no purchaser is not going to be found, it will be demolished by public expense in the near future. (Photos 3.1.5.3-3.1.5.4)

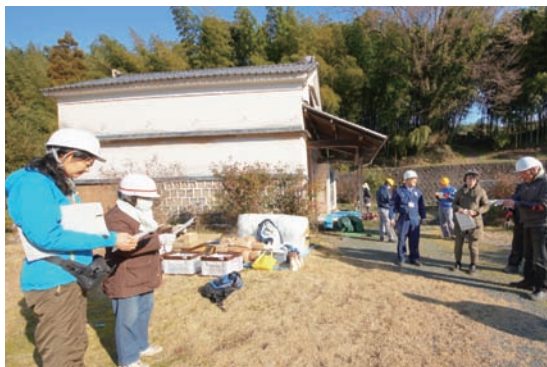
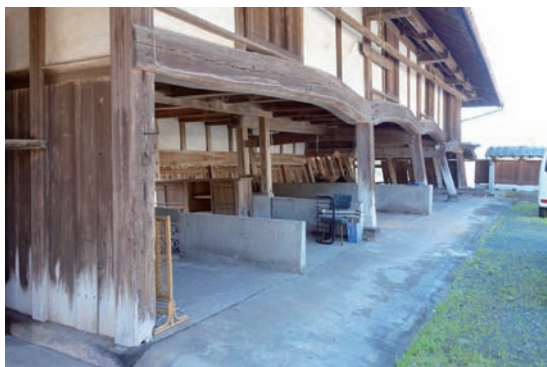
Photos 3.1.5.5-3.1.5.6
Measures to investigate the layout plan, cross section view, construction technique and structure of these vernacular architectures has carried out at the Kawabata family house before they were demolished.

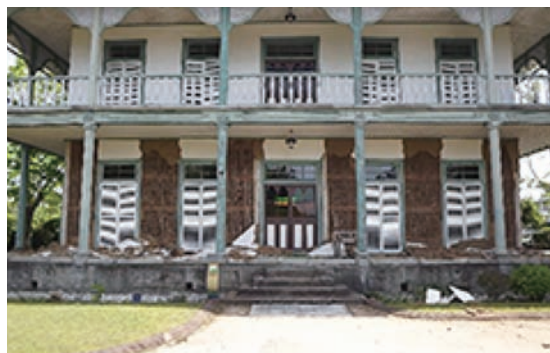
In the fore-shock earthquake of April 14, as is shown in Photos 3.1.6.1 to 3.1.6.4, the earthquake-resisting element of the mud-plastered walls suffered major damage.

Photo 3.1.6.1 The damage caused by the fore-shock earthquake (front).

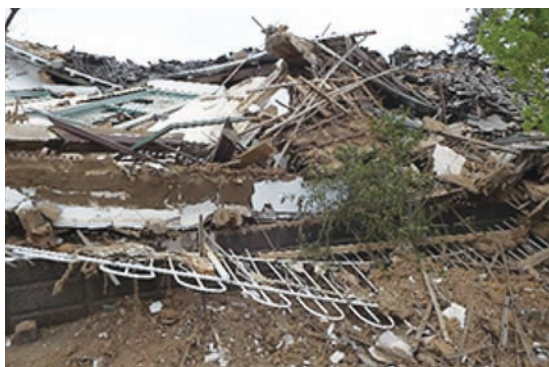
It was then completely destroyed in the April 16 main-shock earthquake, as shown in Photos 3.1.6.5 to 3.1.6.6. There were other wooden houses and buildings around this building, but, at least in terms of their external appearance, they did not suffer any damage, and only this historic property specifically was damaged. In addition, many of the archival documents that were stored inside as the museum collection were damaged. Since the earthquakes, rescue efforts for the documents have been continued by the Janes Promotion and Education

Photo 3.1.6.6 The building was completely destroyed in the main-shock earthquake (2).

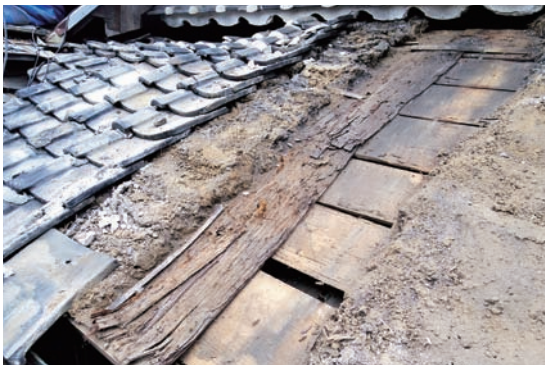
Photo 3.1.7.5 Records of the original condition before removing the roof (main building south annex).

Therefore, the fundamental repair policy is to restore the property on the basis of the historical facts but without excessive focus on the restoration to avoid expensive repairs, carrying out the repairs with the aim of maintaining the site until it can be fully repaired (expected in the future). In the course of repairs, besides supervision by experts in restoring

cultural properties, reference is being made to the specifications of the tiles and walls from the initial construction that have survived within the site. In addition, private records and photos from the Meiji Period to the pre-war periods were referred to. Moreover, samples were kept of the tiles and earthen walls that had to be removed, and photos and other records of them were taken. These are being kept as references for when the full repairs take place.

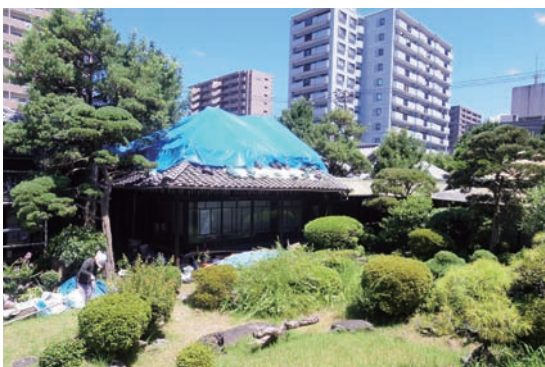
Photo 3.1.7.7 The 15-tatami room awaiting restoration (sitting room).

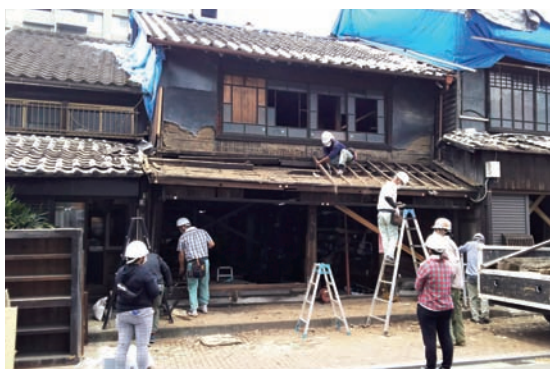
In the store section, which included the *battari shogi*, was designed to create an open space by having few columns, which caused localized deformation during the main shock of the earthquake. In addition, each of the buildings densely constructed within the site had oscillated during the earthquakes, and consequently damages were concentrated at the joints between them. In addition, the falling roof tiles and collapsed earth walls completely changed its appearance, which canceled out all the expense and efforts that the owner had spent to ensure the continuous of these buildings, the damages that were so overwhelming. However, at that point in time, there were only few concerns of collapse, and it was judged that they could be restored, technically speaking.

Photo 3.1.8.1 The facade immediately after the disaster.

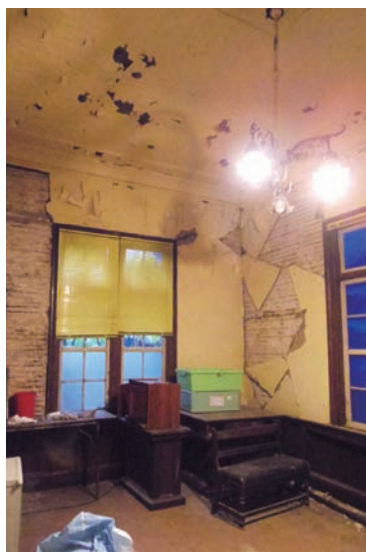
Although the buildings escaped collapse in the main-shock earthquake, there were localized damages, such as the loss of pillars in the entrance hall. From a visual inspection, it is estimated that, on the basis of the partially collapsed outer walls, there was widespread rotting and ant damage to the wall bases and structural materials. In addition, the falling of plaster from the interior walls was extremely severe, and the owners had to spend a huge amount of time to clean it up that also created

Photo 3.1.9.2 The interior after the disaster.

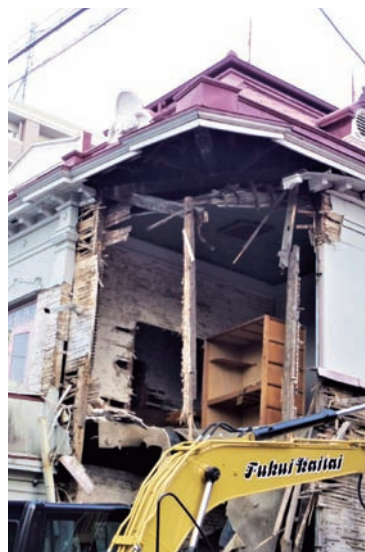
Photo 3.1.9.3 During the dismantling.

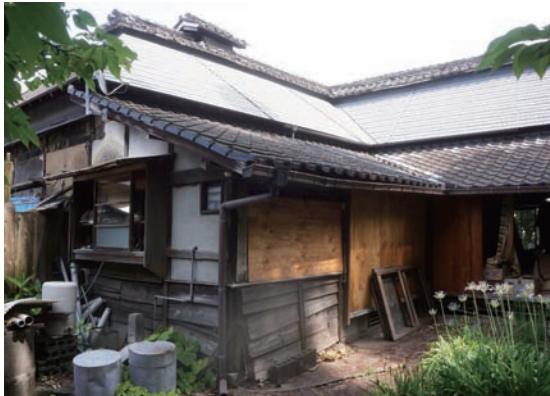
Photo 3.1.10.3 The protruding earth floor section.

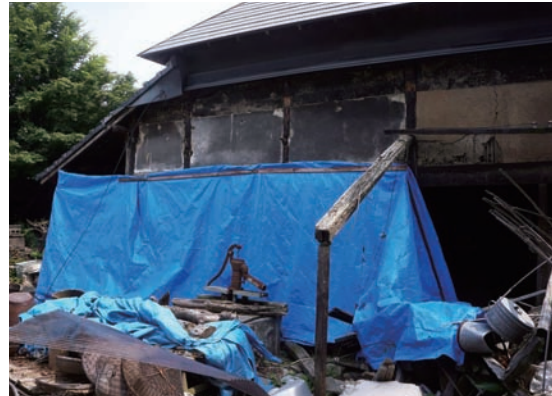
The buildings suffered various kinds of damage in the recent earthquakes, including the collapse of earth walls and the displacement of roof tiles. Overall, the damage was kept down to partial destruction, but it was comparatively large in the small annexes and the toilet. T, The small annex (es) north to the earth floor collapsed, and the wall at the edge of the earth floor collapsed. In addition, the floor of the small annex on the north of the anteroom collapsed. The wall of the toilet and the floor of the corridor also collapsed. After these places, the damage was next greatest in the sitting room. The alcove's *otoshikake* (a bar placed across the upper part of the alcove) fell down, the wall collapsed, and the alcove's transom bar fell down. In the sitting room, the columns acquired an incline (in a southwest direction) of 1/30. In addition, the floor of the six-tatami room on the east side of the entrance collapsed.

Photo 3.1.10.4 The collapsed small annex on the earth floor north side.

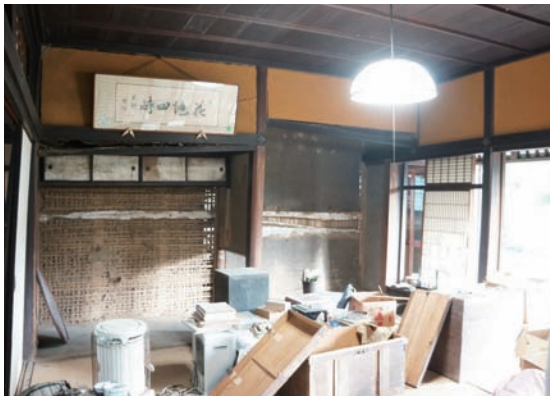
Photo 3.1.10.5 The sitting room: Collapsed interior earth wall.

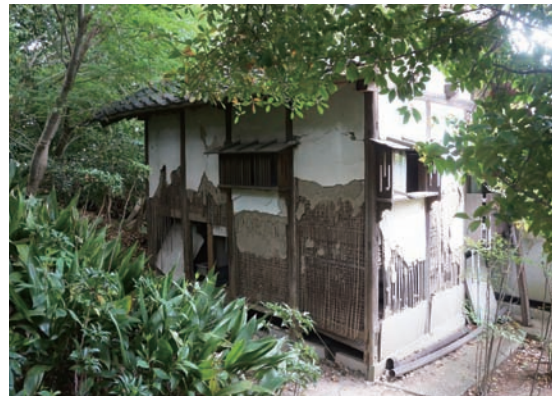
Photo 3.1.10.6 The toilet: Collapsed earth wall.

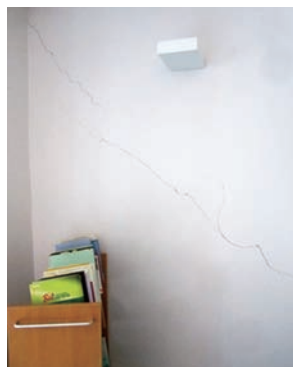
Photo 3.2.1.4 Shear cracks appeared in the walls.

due to this out-of-plane bending deformation were observed at the corners. Moreover, cracks due to bending of the walls were seen. Shear cracks also appeared on the surfaces of the plaster-finish walls (although the width of these cracks were small) (See Photo 3.2.1.4). A more detailed investigation would be needed in order to ascertain whether these cracks only occurred in the finished plaster, whether they reach as far as the interior of the brick masonry, or whether they penetrate all the way through the walls.

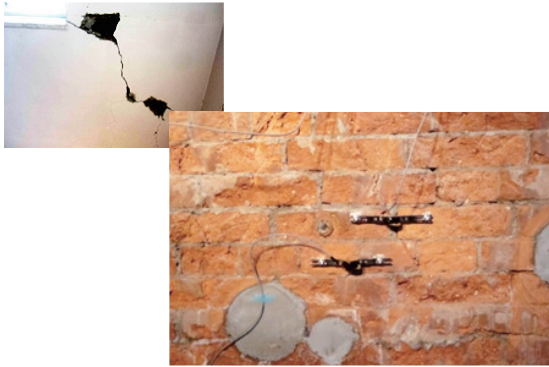
With the cracks appearing in the brick wall in this way, in order to confirm whether the walls remained structurally stable, monitoring of the crack displacement (width) had been carried out. As crack displacement is affected by temperature, clarifying their relationship with temperature change was essential for the evaluation. On the basis of the above, in order to ascertain the movements of the crack displacements and to evaluate the soundness of the building, a crack displacement monitoring survey had been conducted to confirm the effects of the temperature fluctuations on the crack displacements (See Photo 3.2.1.5)

From Figure 3.2.1.6, the structure was judged to be stable, because no significant changes were seen over the day, even though the crack displacement (width) repeatedly fluctuated over a one-day period due to temperature changes. It is useful to have

Photo 3.2.1.5 Monitoring the crack displacements in the brick walls.

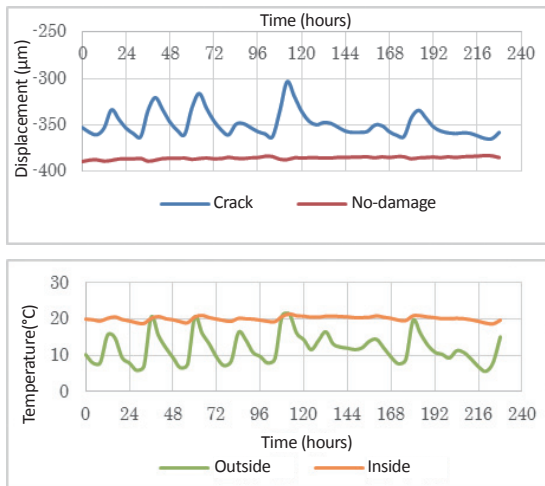
Figure 3.2.1.6 Monitoring the crack displacements and temperatures (upper: crack displacements μm , lower: temperature in and outside the room).

long-term monitoring records of damaged masonry structures; furthermore, it is preferable to conduct long-term measurements.

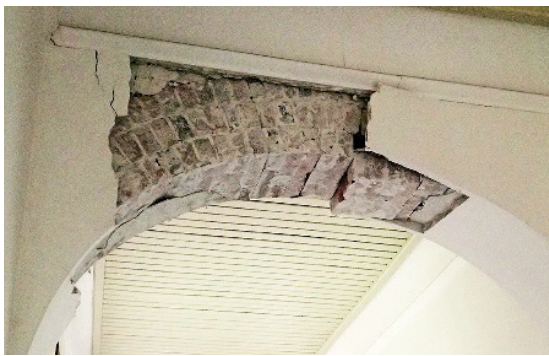
Other severe damages were observed at the center of the arches in the corridor on the second floor, which connect the classroom dividing walls with the long walls on the south front. These arches support the front wall and prevent it from falling with its exterior buttresses. At the center of the arches, the surface plaster was fallen down and the bricks to form arches were exposed. Some of their bricks are fallen down as the time passed by and it is causing dangerous situation. The damage from the earthquake was more severe on the 2nd floor due to the height from the ground level.

Photo 3.2.2.3 Cracks and fall down of the surface plaster on the corridor arch. (The Fifth High School Main Building)

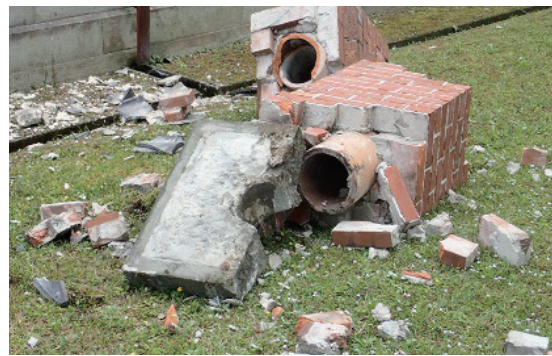
The Lab Building, built of brick in 1889 and 42.5 m long from north to south, was used for chemical experiments and lectures. It was not damaged much because it is single storied low building with transversal walls. The fall and shift of several chimneys was conspicuous. Some minor cracks on the interior wall were observed.

Photo 3.2.2.4 Fragments of a chimney on the ground. (The Fifth High School Chemical Lab.)

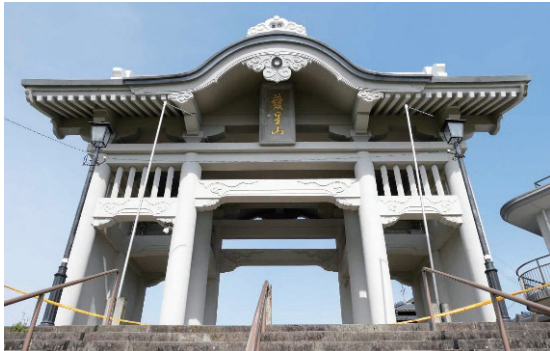
Photo 3.3.1.1 Honmyo-ji Nio-mon: front.

in July 2017. The noteworthy items in this report are that [1] the differential settlement of building is extensive, and the south side's column bases (left side of Photo 3.3.1.1) have sunk by around 120mm

more than those on the north side, which is the main reason for the gate's incline (it is also one of the causes of the damage to the column-beam joints); [2] the columns and RC piles are directly connected,

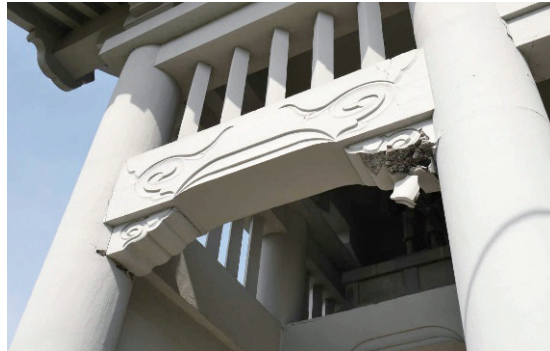
Photo 3.3.1.2 Honmyo-ji Nio-mon: front.

Following the recent earthquakes, various kinds of damages to the Deva gate were confirmed, including [1] flexural cracks around the joints between columns and middle beams, [2] detached bracket arms, [3] damages around column bases, and [4] shear cracks on the walls below gables. The 12 columns that constitute the gate are connected at their upper and middle sections by beams, and because the weight and rigidity of upper sections above middle beams are extremely large, it was observed that flexural deformations of the lower sections were more prominent than at the upper sections. The flexural damages were also more pronounced in the gate's longitudinal direction than in the transversal direction, and in its transversal direction, the damages were greater at its two central column rows than at the side end column rows that were infilled with walls. Although the widths of wall cracks were narrow, there were concerns that the rigidity of the walls had been reduced.

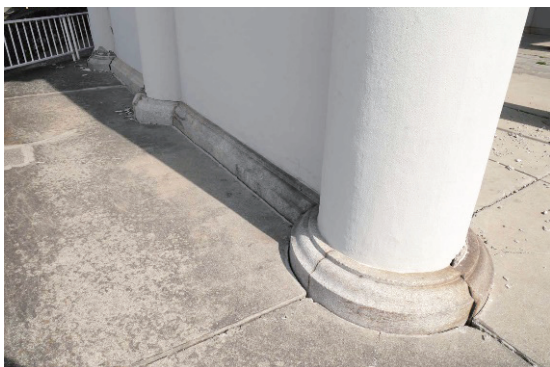
Some damages are also found on the concrete ground slab around column bases. The slab at the back of Photo 3.3.1.3 would seem to have been partially removed to create enough space for vehicles to pass, because the extent of concrete ground slab is smaller than that of other columns, thus it is possible that this fact increased damages and subsidence around the column base.

Photo 3.3.1.3 Honmyo-ji Nio-mon: column bases and the surrounding area.

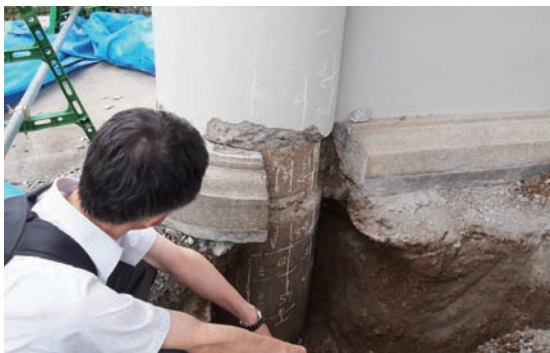
Photo 3.3.1.5 Honmyo-ji Nio-mon: the state of the ground around the column base.

and the damages that can be seen in Photo 3.3.1.4 are almost completely limited to the strips of stone footings and their adjacent areas; and [4] there are no ground beams or footings (Photo 3.3.1.5) as well as the extremely weak soil condition from 3m to 11m underground, so it is highly possible that this is the cause of the defects to piles penetrating this ground. Going forward, the results of other surveys are going to be reported, the seismic capacity of the building will also be evaluated, and seismic retrofitting will be assessed on the basis of these surveys and evaluations as scheduled. (Photos 3.3.1.1-3.3.1.4, 3.3.1.6 taken by the author, Photo 3.3.1.5 taken by Mariko Nishijima.)

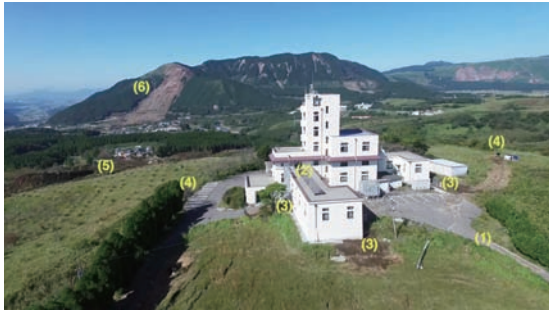
Photo 3.3.2.1 This is an aerial photograph taken of the Aso Volcanological Laboratory and its surrounding area on October 24, 2016. In the far distance can be seen Mount Unzen on the Shimabara Peninsula. Below are the explanations of (1) to (6) in the photograph.

- (1) From July to August 2016, one part of the access road to the Aso Volcanological Laboratory and the road within its site were temporarily repaired. This made it possible to access the Laboratory's buildings using an ordinary car.

- (2) August 2016: Emergency measures were implemented to prevent water leaking into the buildings from the cracks.
- (3) September to October 2016: A damage survey of the foundation was conducted.

- (6) Repair work is in progress at the sites of collapse on National Highway 57, the JR Houhi Line, and the Aso Ohashi Bridge. However, it has not been determined when the repair work will be completed.

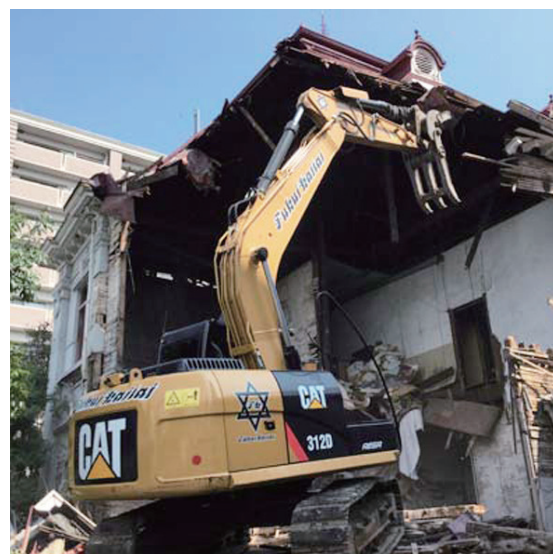
Photo 3.4.1.4 A townscape-formation building being dismantled (July 2017).

Despite the arduous “life-saving” efforts made in the year after the earthquakes, two townscape-constituting properties had to be dismantled one after the other in June and July 2017 (Photo 3.4.1.4). Going forward, in order to maintain the historic landscape over the long term, it is hoped that:

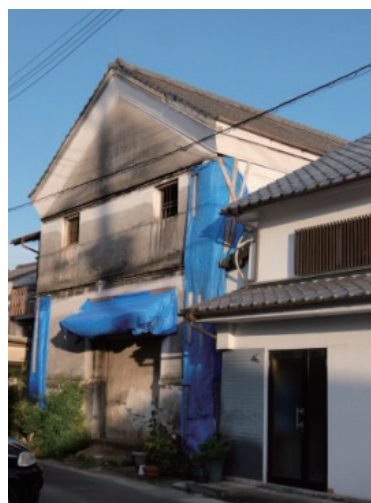
Photo 3.4.2.4 Warehouse in the town

was great. In one square kilometer, there are over 60 dismantled buildings, old and new. There remained a privately owned warehouse. There is no relief system. There is the “Town Development Subsidies Project,” but a structure is not eligible for

this unless it faces the road. Repairs are possible at a very small cost, but a flexible response is required. (Photos: a warehouse in the town, a map of the dismantled structures)

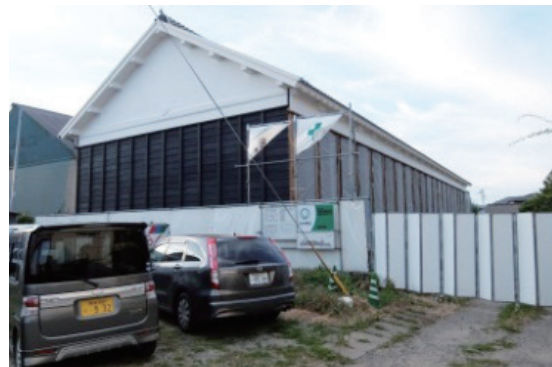
Photo 3.4.2.10 The Hosokawa Domain rice granary (nationally designated)

- The nationally designated Hosokawa clan rice granary is undergoing construction work, and as the earthquakes occurred before the roof and walls were installed, the building was light and suffered hardly any damage. The restoration work will be completed in November, as planned. (Photo: the Hosokawa rice granary)

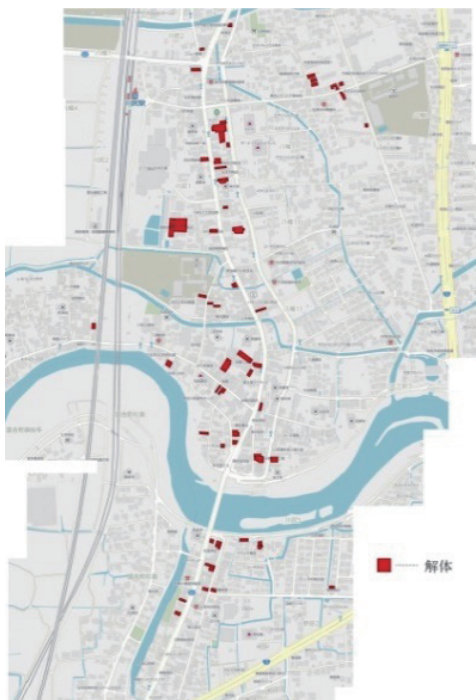
Photo 3.4.2.11 Dismantling in the Kawashiri District (60 buildings)

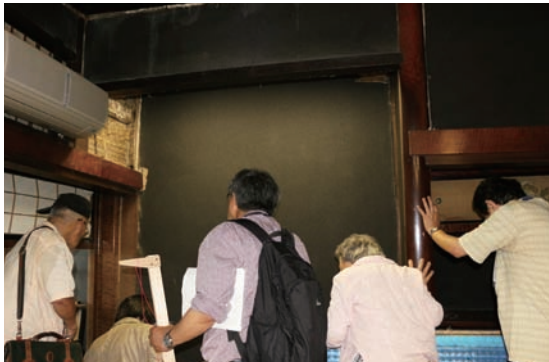
Photo 3.4.3.3 Architects inspected each townhouse and provided advice on repairs.

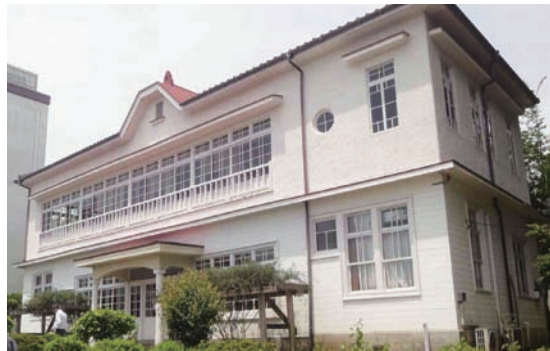
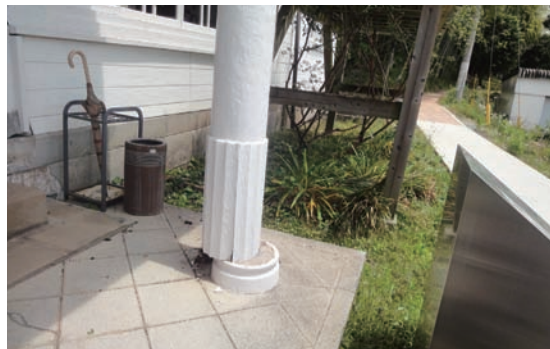
Photos 3.5.2 The Riddell-Wright Memorial Hall

A research facility for Hansen’s disease (leprosy) established by two female, Ms Riddell and MsWright. It is two-storey building with a long, east-west rectangular shape. The building suffered from various kinds of damages caused by the earthquakes, as the ground at the south elevation was shifted forward by around 10cm. Along with this ground shift, cracks had appeared onto its foundation, columns became misaligned, and some parts of internal walls were peeled off. A large-scale construction works is required, including jacking up the building to replace it to its original position. It had been used as an exhibition hall, however it is currently closed.

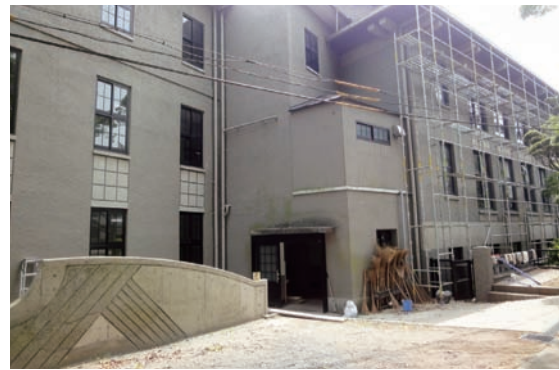
Photos 3.5.4 Kyushu Jogakuin High School main building

The main building of a missionary school designed by Vogel, an American architect. There were cracks

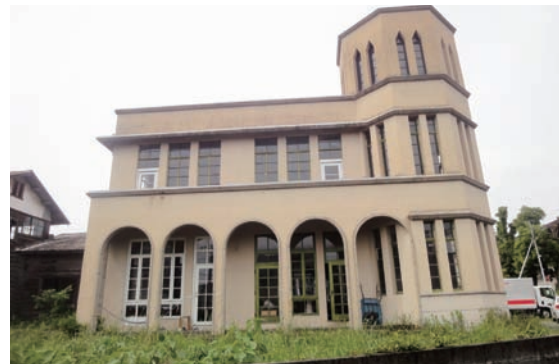
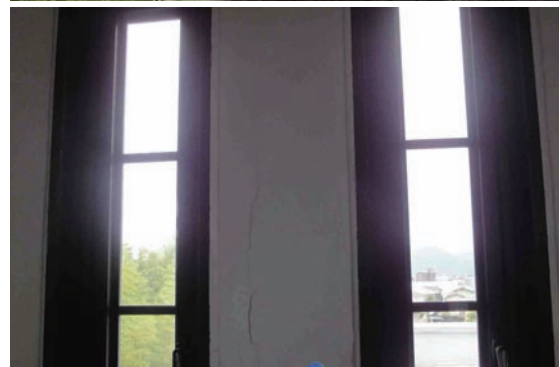
Photos 3.5.5 A meeting hall for Bible study

A meeting hall for Bible study that was built with donations, from the North American YMCA, volunteers from the former No.5 Senior High School and such. Cracks were observed in the internal wall of its penthouse, other than that, no other major damages were found.

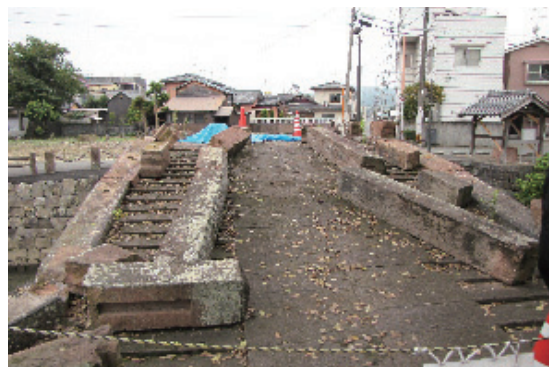
Photo 3.6.1.3 The bridge post collapsed at the Senba Bridge

A single-arch bridge built in 1863 on the Senbagawa River, Uto City, the Senba Bridge is a city-designated cultural property. As shown in Photo 3.6.1.3, the damage to this bridge due to the earthquake occurred more on the upstream side than on the downstream side. The damage included cross-sectional deficit and continuous cracks in the arch stones. In addition, on the road surface, the balustrades and the bundling pillars collapsed, the wheel guard and road surface stone materials suffered deformation, and some of the balustrades fell into the river.

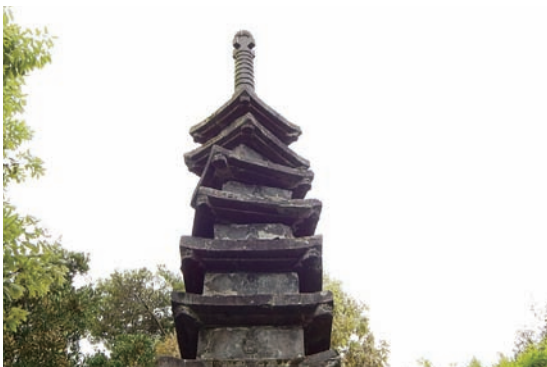
of these earthquakes, the top four stories and the roof of the pagoda rotated and some of the stone materials were damaged. Afterwards, the stone materials that suffered heavy damage at the fifth story and above were quickly dismantled and stored, and that made it possible to avoid collapse or other major damage during the after-shocks. There were center holes in the stone materials used for the pagodas and in the roof, so it is highly possible that there was something like a center pillar at the time of the original construction, but this pillar was not installed when it was relocated in the present site. Moreover, lead boards have been used at the upper end of the pagoda to adjust the unevenness in the stone materials.

Photo 3.6.2.2 The upper part of the twisted thirteen-storied pagoda

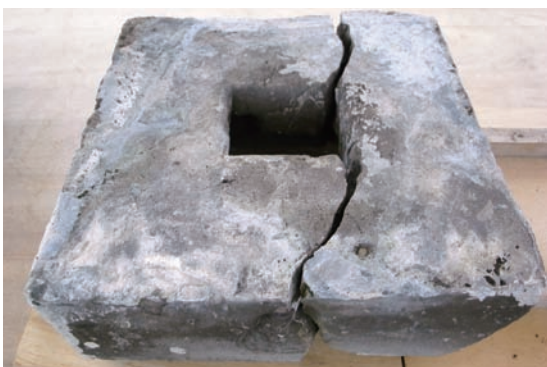
The stone materials that suffered severe damage were on the fifth story, which split into two large sections (Photo 3.6.2.4), and on the seventh story,

Photo 3.6.2.4 The damaged fifth story of the pagoda

which roof was fragmented at the eave-ends. They are being reinforced using stainless steel dowel pins and epoxy resin combined together and, in order to improve earthquake-resistance, stainless steel core post is to be installed during reassembly.

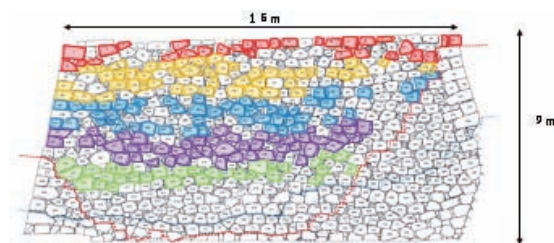
Figure 3.7.1.9 An elevation diagram of the Miyauchi dry stone wall

Ninomaru castle compound, the protrusion of the lower part had become so conspicuous that in 2003 repair works were carried out, assigning numbers to the stones while temporarily dismantling them, to re-pile them up again. In these recent earthquakes, the damaged parts corresponded almost exactly to those previously repaired, and it was possible to determine the original positions of the collapsed stones.

The stones in the lowermost four levels of the collapsed area fell to lay face down directly beneath the stone wall, and were covered by the backfill cobblestones. Then, on top of these, the upper construction stones fell and spread in a semi-circular shape, but retaining the vertical relationship between them. In other words, this situation suggests that the collapse occurred in an instant, with the lowest part of the collapsed section collapsing first, followed by the backfill cobblestones, which flow out, while the upper part of the stone wall slid off retaining the vertical relationship that existed prior to the collapse, thus fell at once.

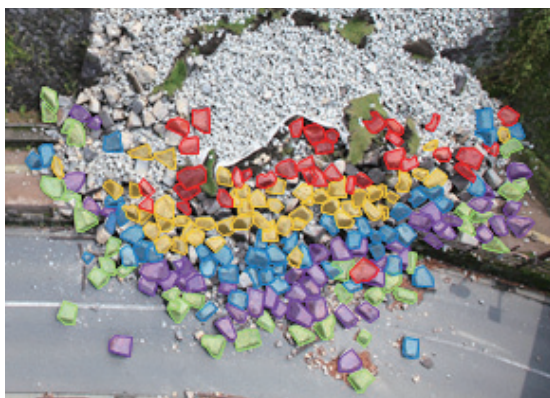
Figure 3.7.1.10 The collapsed Miyauchi dry stone wall
